MTS DP CONFERENCE

2002

'PROBLEMS' SESSION

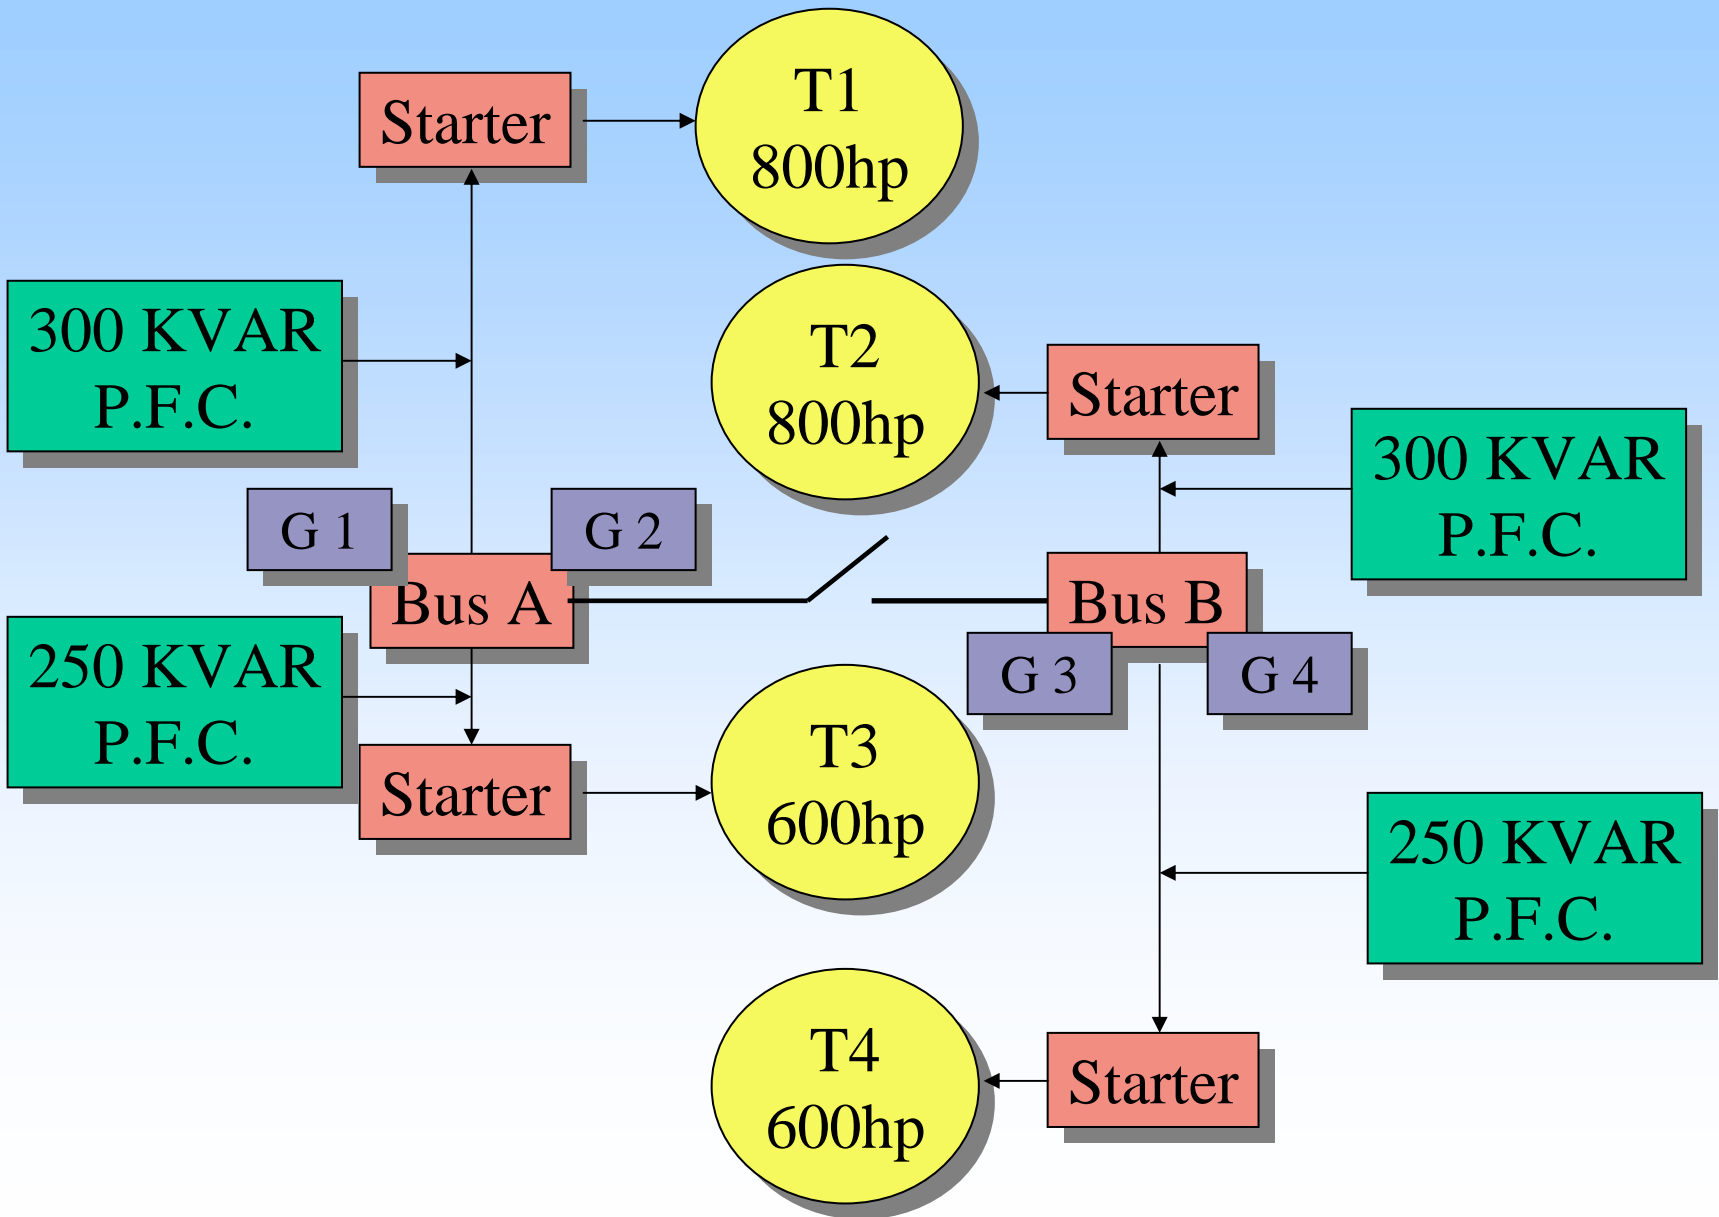
The Solution

- **ABS required all 4 generators on line for DP-2 operation.**
- **The maximum current load of each bus exceeded the amp capacity of a single generator.**
- **The ship had no power management system installed.**

- **Stolt proposed installation of an ABB Automatic Power Factor Correction Unit (PFC)**
- **ABS approved the PFC installation**
- **It was theoretically sound but they were not very sure that it would work.**
- **But it did work!! - here is the solution.**

- **Buss A - uncorrected - load 1768 Amps**
- **- corrected - load 1479 Amps**
- **- single gen capacity 1683 Amps**
- **- spare 204 Amps**

- **Buss B - uncorrected - load 1733 Amps**
- **- corrected - load 1448 Amps**
- **- single gen capacity 1683 Amps**
- **- spare 235 Amps**

- **Installation of automatic PFCs resulted in a lower than calculated current at 100% thrust.**
- **Very soft starting of the thruster motors,**
- **A practical alternative to power management on a 20 plus year old ship**
- **A very simple system installed in days.**

- **The ship can operate in DP 2 mode with only two generators running.**
- **A generator can be down for service.**
- **A ‘normal’ power management would still have required all four to be available for DP 2 ops.**
- **The cost of the PFCs was less than a third of the lowest quote for any other system.**

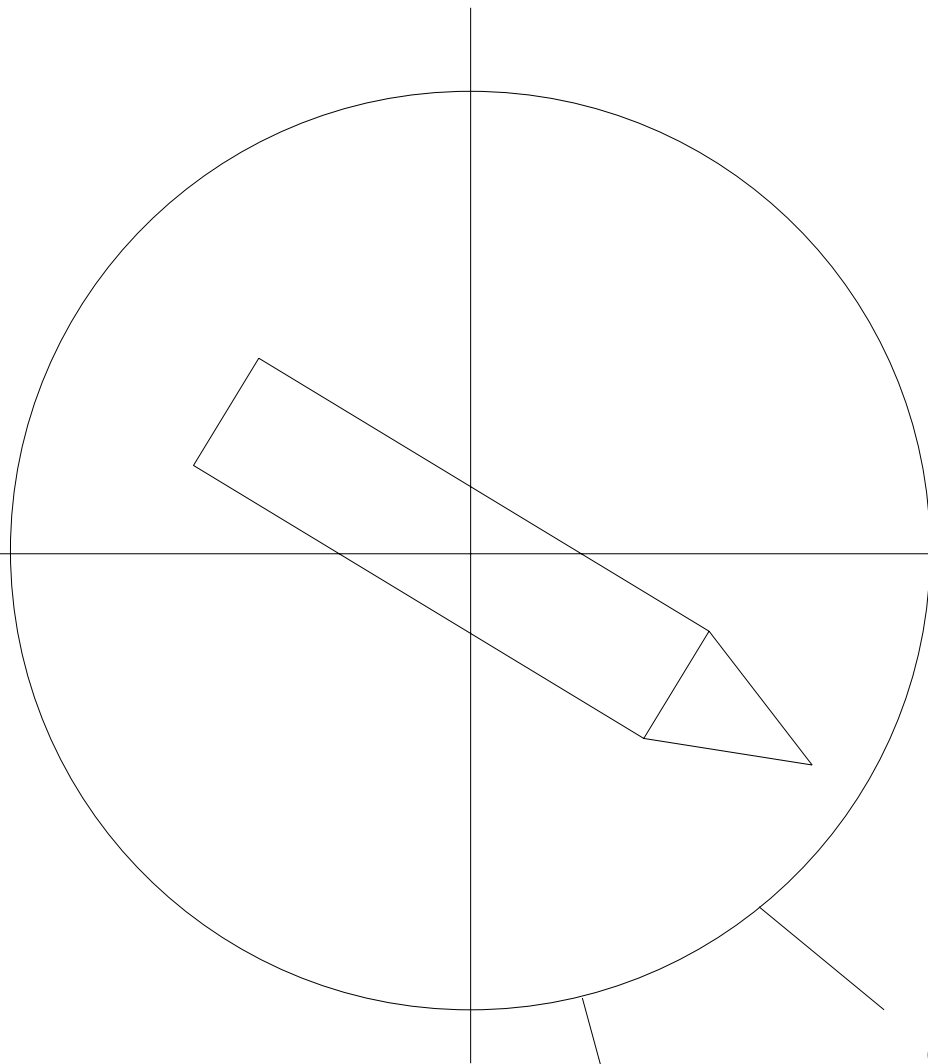
Vessel Heading 120 deg

Wind SE 40 kts

Predicted to shift from SE to SW
Diminishing to 25 kts

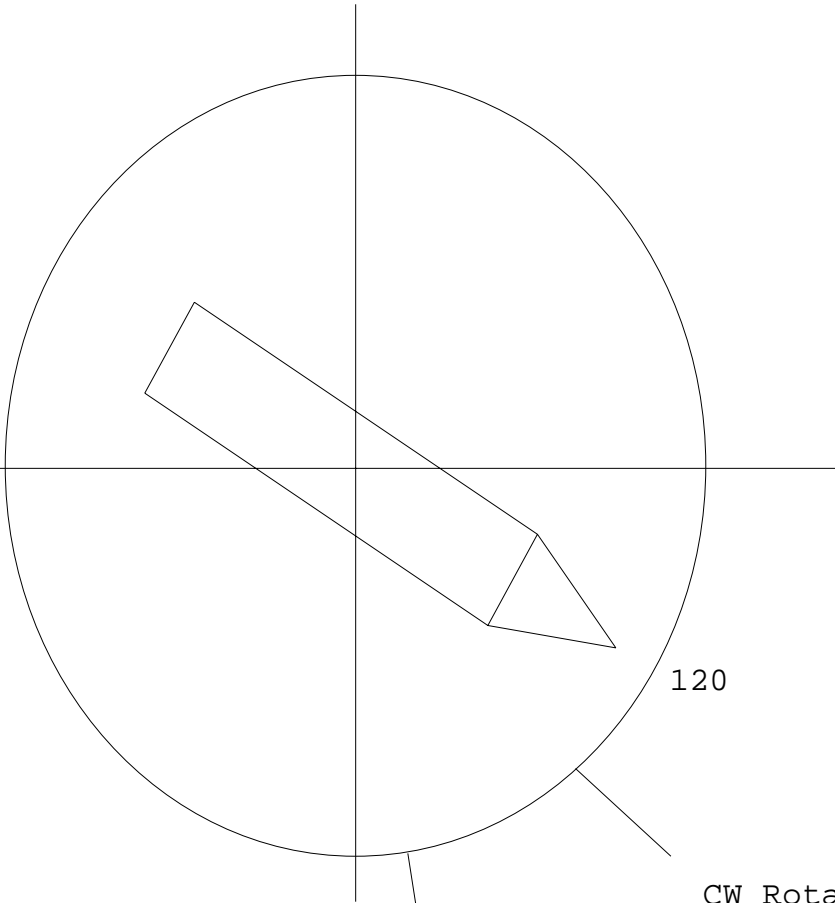
Current from SE at approx. 2.5 kts

Wind 40 kts from 160 deg. (40 deg off stbd bow)

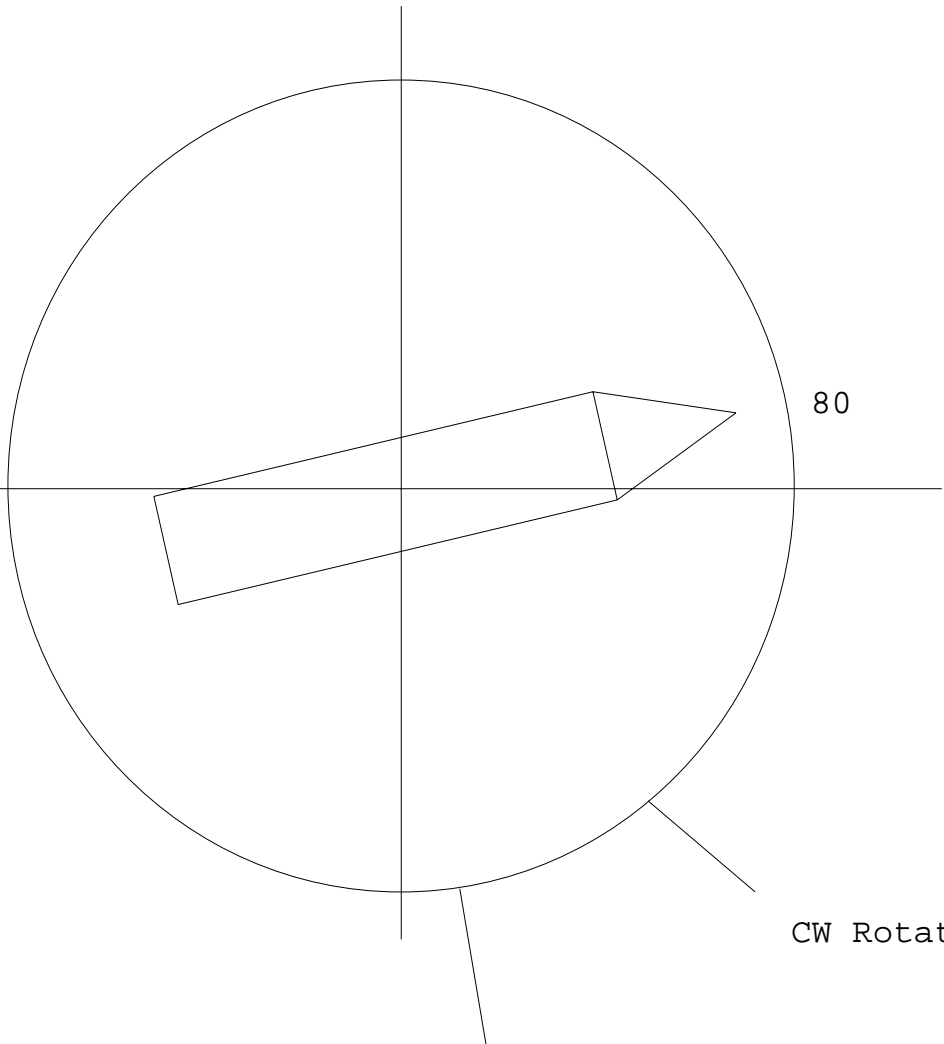
25 feet off location

Current from SE at approx. 2.5 kts

Wind 40 kts from 155 deg (beam on)

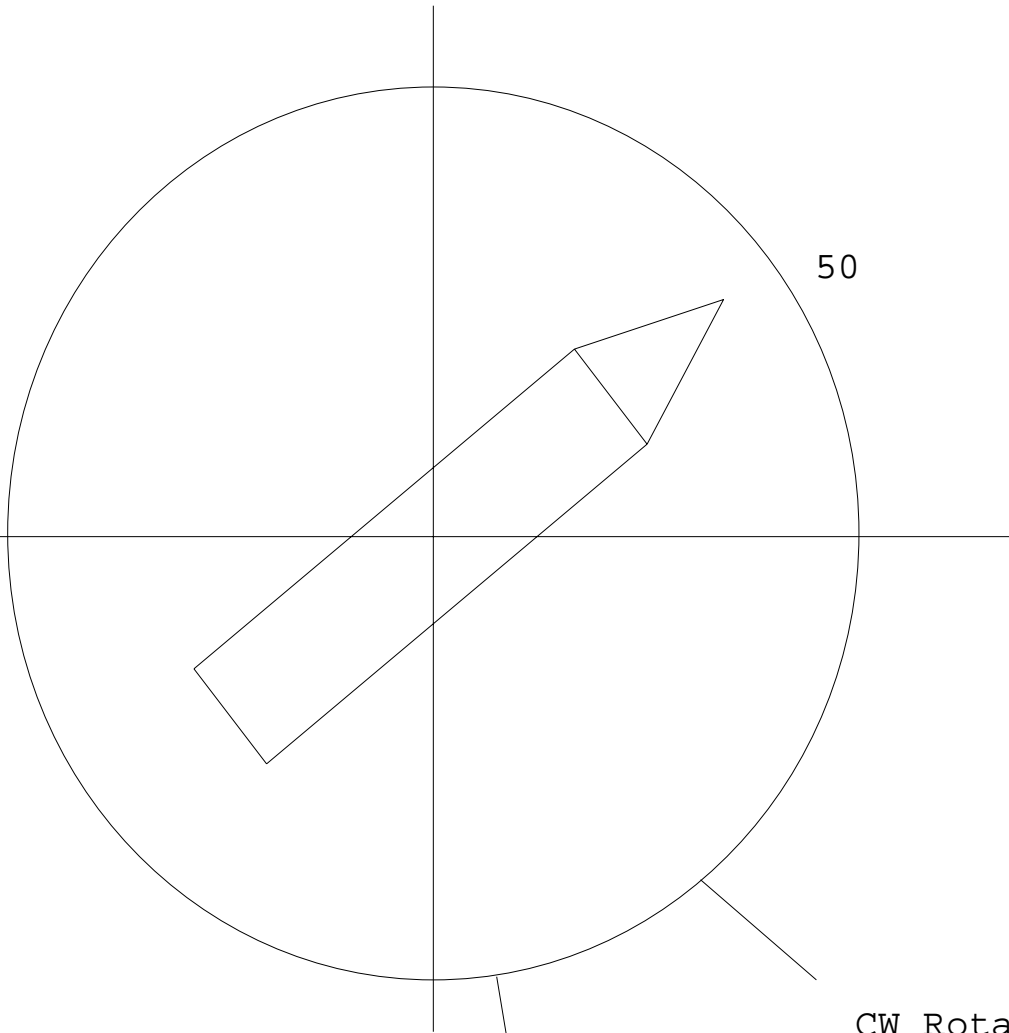
164 feet off location

40 kt winds and 2.5 kt current
both beam on

- **Excessive confidence in weather predictions**
- **Automatically following wind**
- **Repeatedly modifying rate settings**
- **Changing position set point**
- **Consider heading limits**

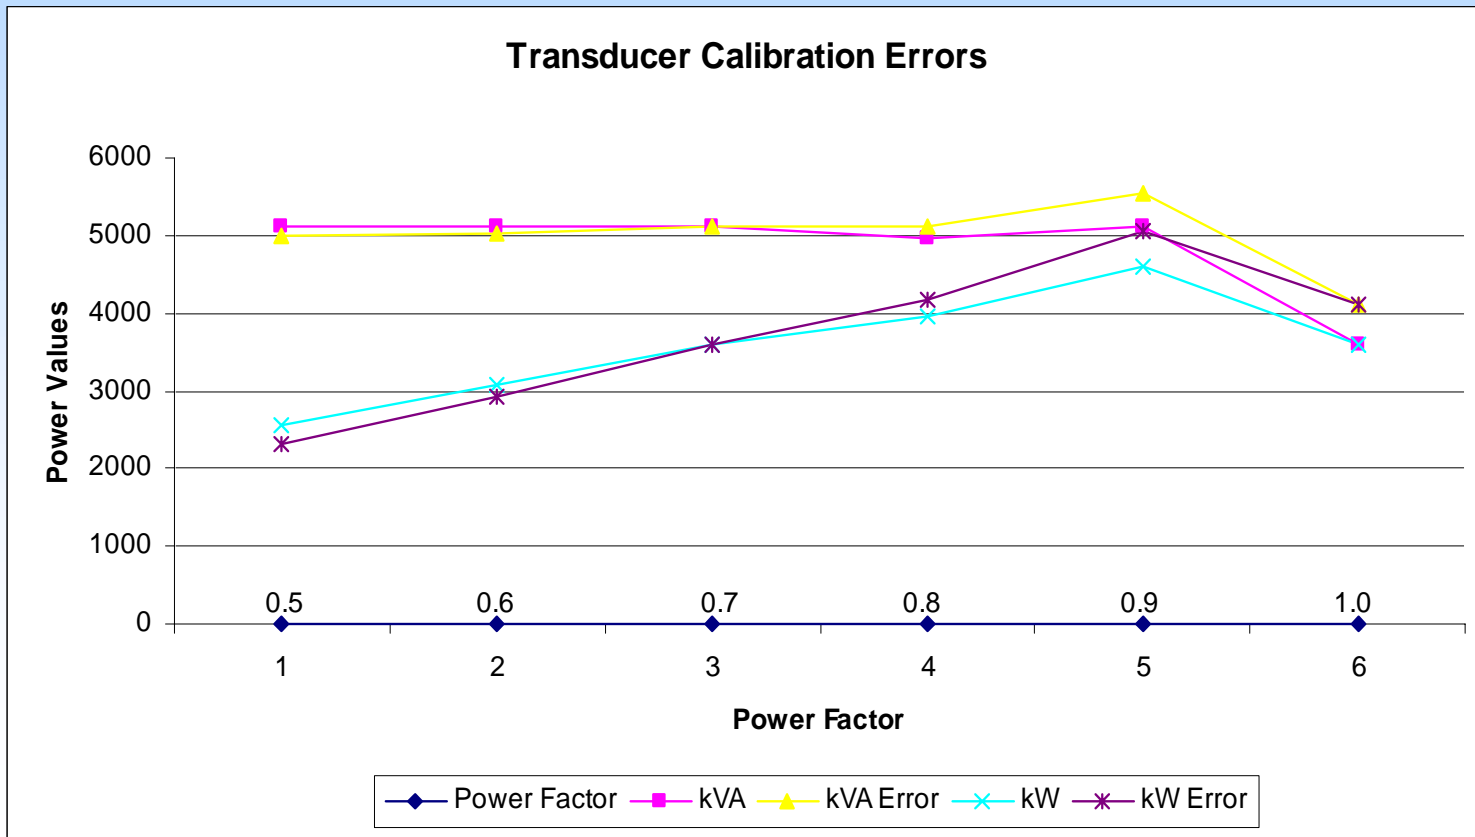
Calibration Data

kW and kVAR Transducers on the E7500 did not output the correct values at all power factors.

Values were correct for 0.7 power factor but a 5% error for every 0.1 of power factor.

First indication of a problem was that the full scale output could not be adjusted for 120% of full scale value.

The following table and graph shows the differences between the calibration values of the two units.

- Use Three-Phase Test Equipment to verify all Calibrations and Calculations

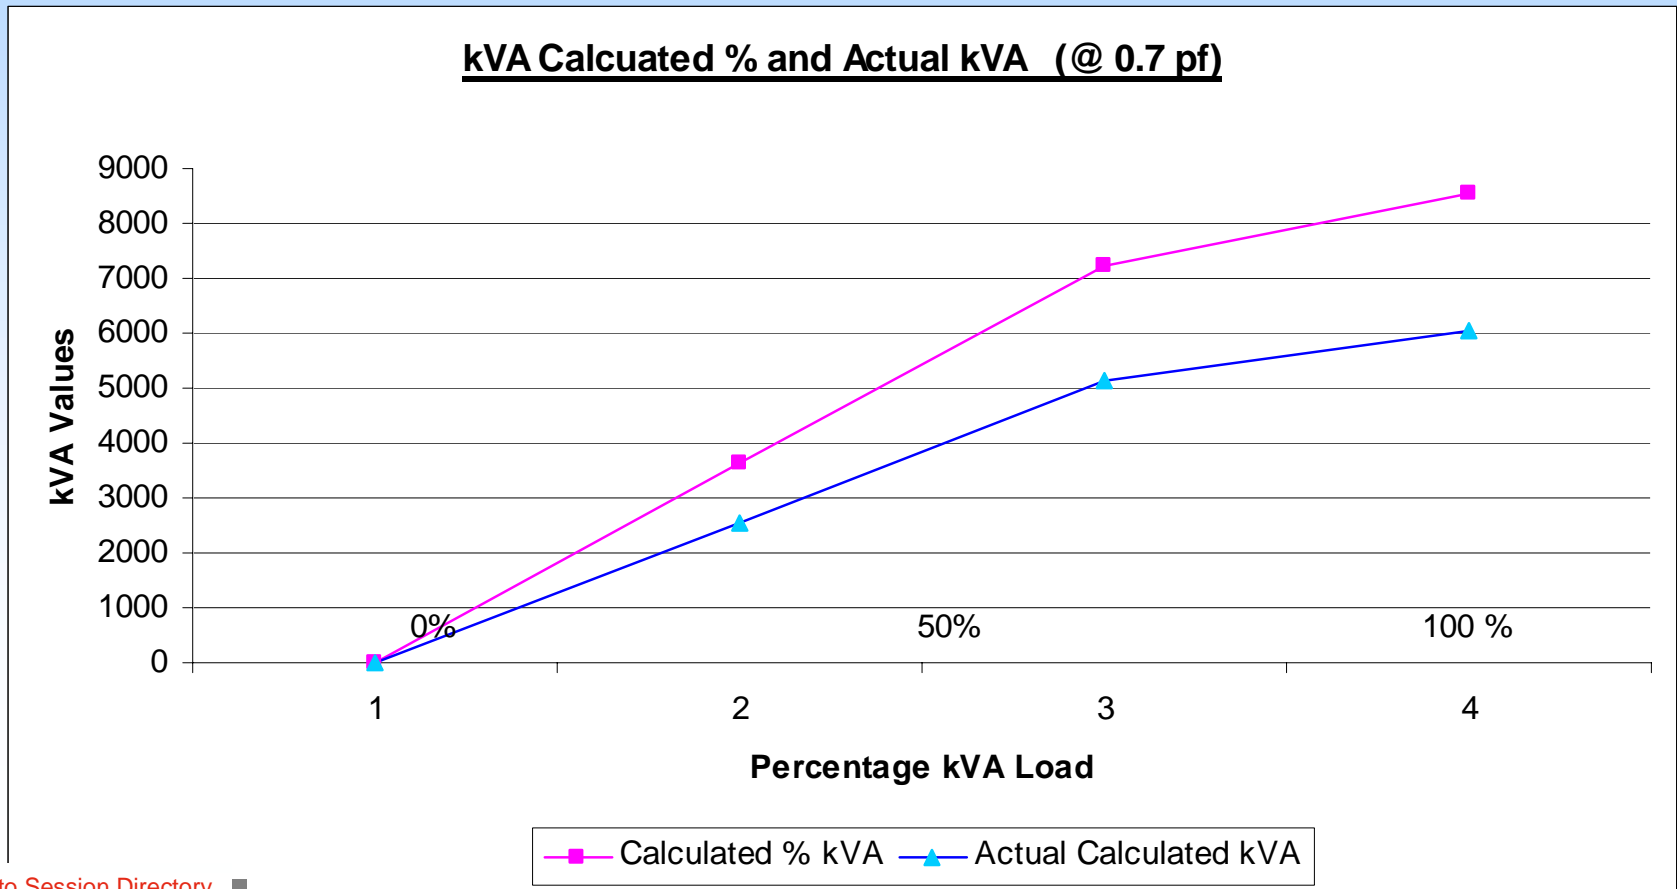
Software Calculation Errors

Using Percentages of kW and kVAR causes error in calculating kVA. The analog values for kW and kVAR are read by the control system. A percentage of full capacity is calculated then this value was used to calculate the kVA. This gives an incorrect result as shown in the graph below. The bottom line is the actual calculated kVA and the top line is the in correctly determined value.

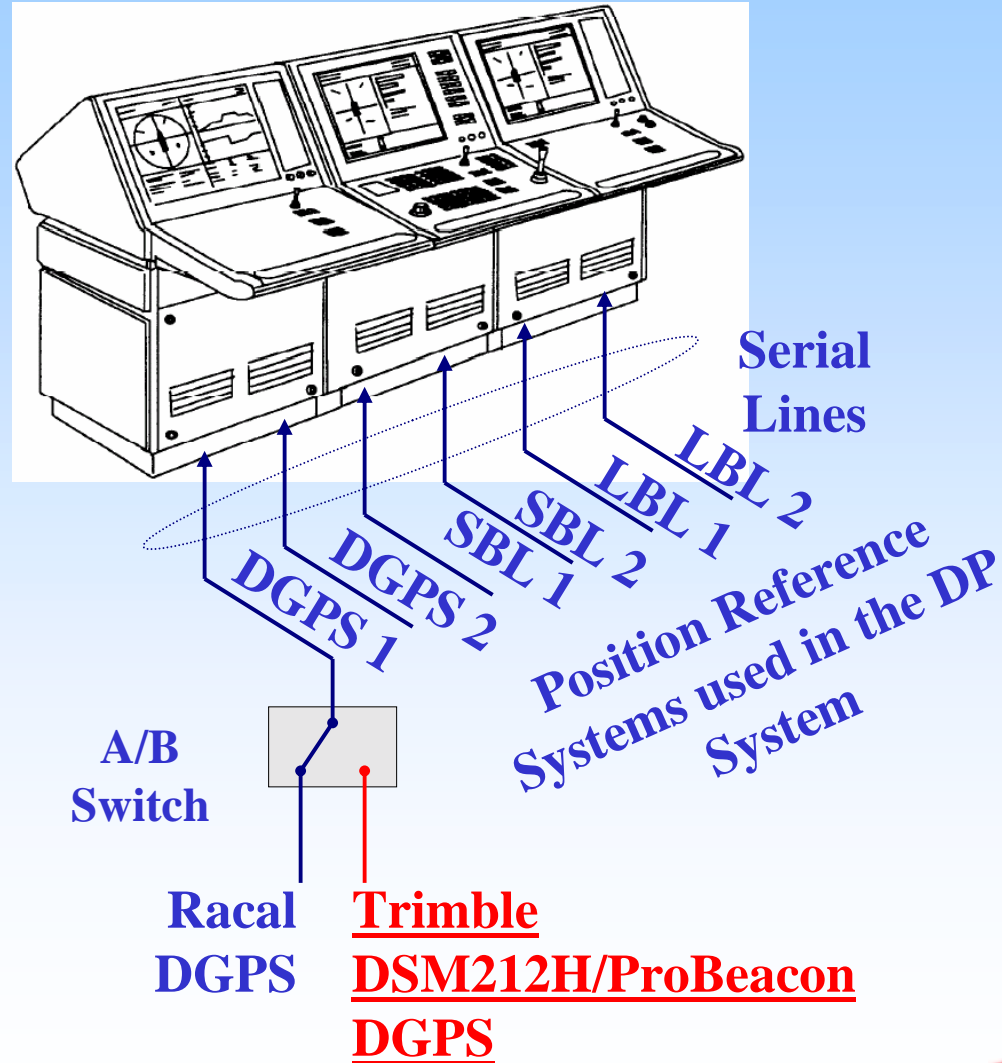
1.1. Root Cause of DP Incident

Faulty Component:	<i>Trimble DSM212H/ProBeacon DGPS wrongly configured</i>
Fault Description:	<i>2 NMEA data strings sent continuously from the TX port</i>
Event triggered by:	<i>Selecting faulty DGPS with A/B Switch into DP System</i>
Event started at:	<i>8:11:56</i>
Event stopped at:	<i>8:21:45</i>
Stop triggered by:	<i>De-selecting DGPS with A/B Switch</i>
Consequence	<i>DP Computers overloaded appeared less overloaded than Computers B & C</i>

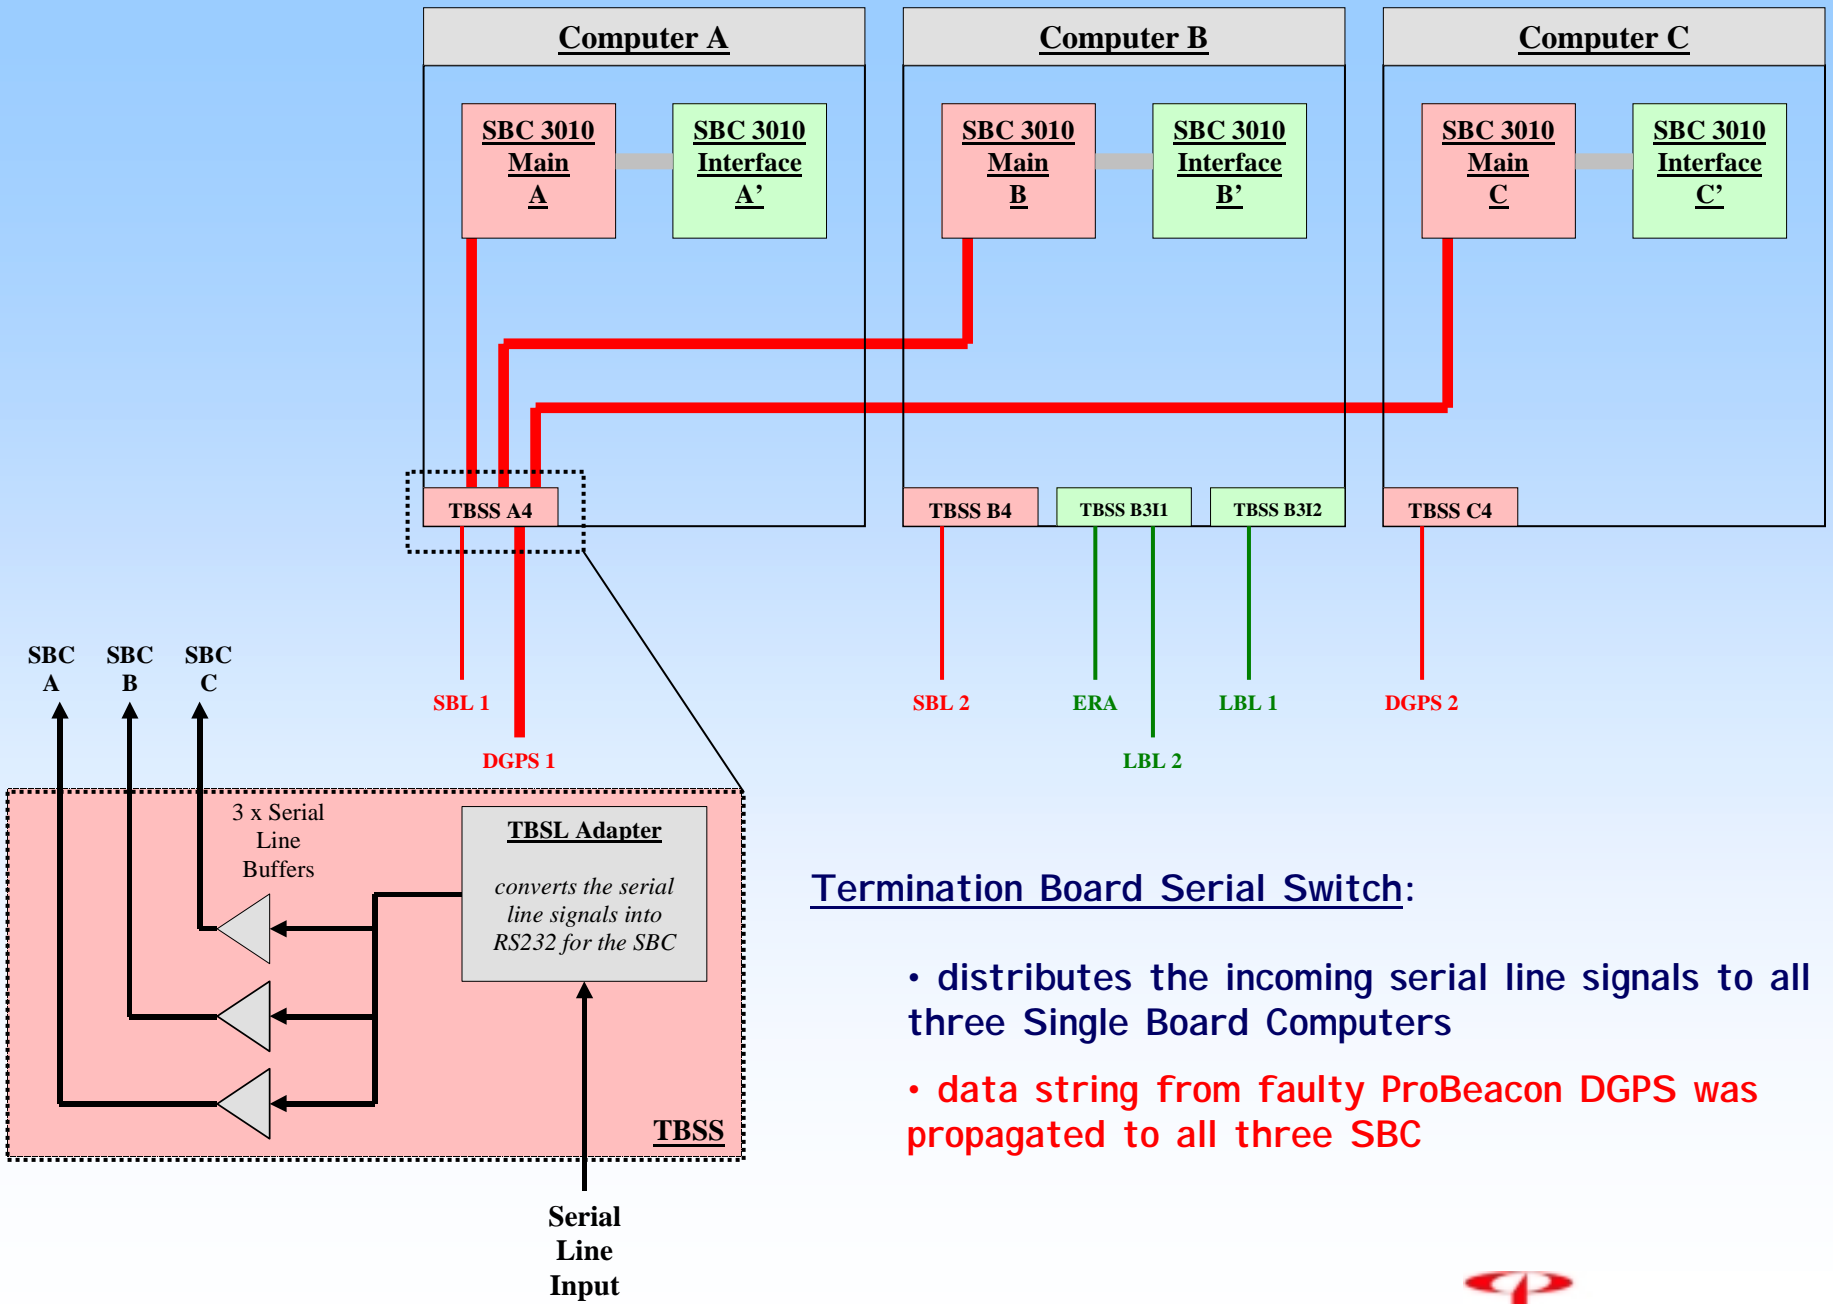
Why did a fault on a serial line propagate to all DP Computers?

Termination Board Serial Switch:

- distributes the incoming serial line signals to all three Single Board Computers
- data string from faulty ProBeacon DGPS was propagated to all three SBC

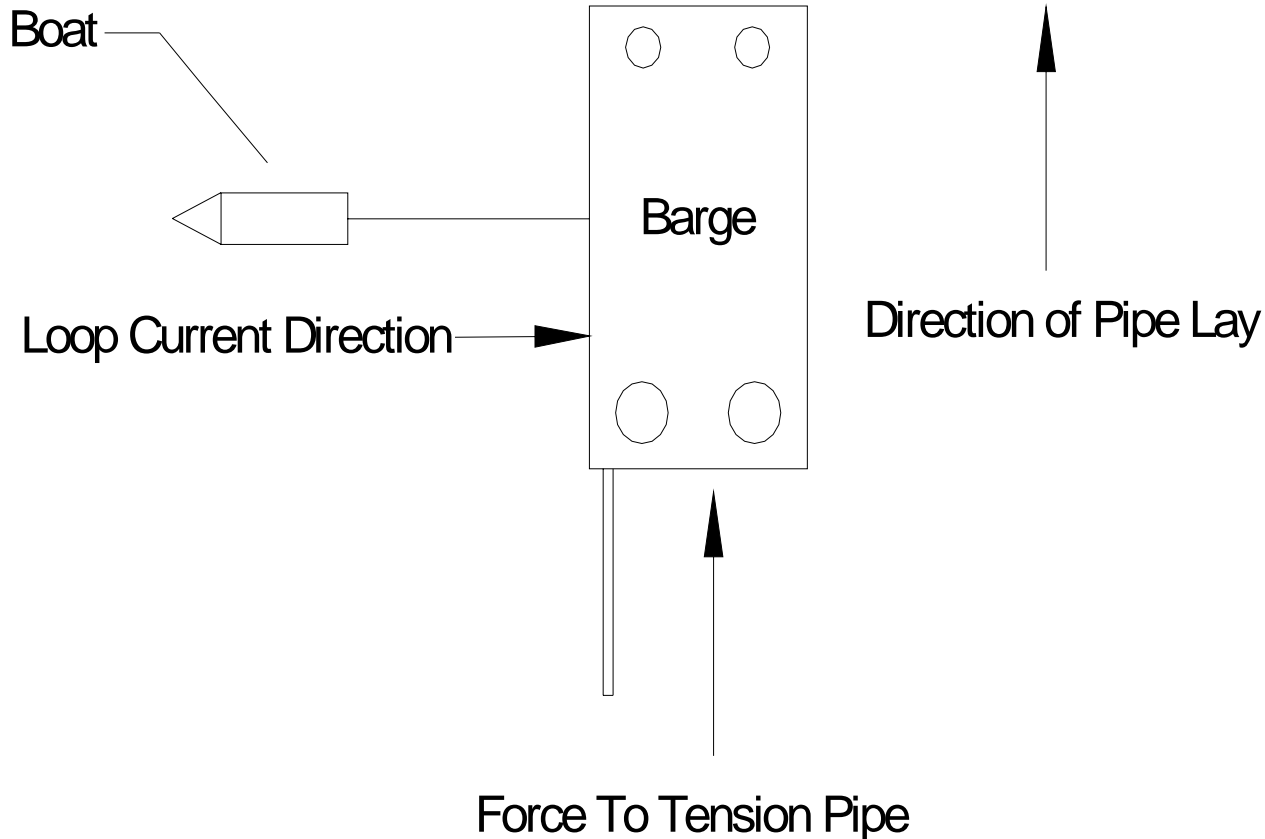
Lay Barge/Boat Configuration

- This situation applies to a DP barge in the process of laying pipe.
- While laying pipe the vessel cannot arbitrarily change heading.
- Current can increase to the point that its force exceeds the vessel thrust capability (mainly applies to small vessels).

Force (lbs.)
Total Thrust Power	78,000
Power To Tension Pipe	20,000
Power To Position	58,000
Force Due To Current (3 knots)	67,000
Deficit of Power	9,000

The solution to this problem is to get additional help from a boat.

Experience using a boat to assist the barge counteract the current force enabled the pipe lay operation to continue in high current situations.

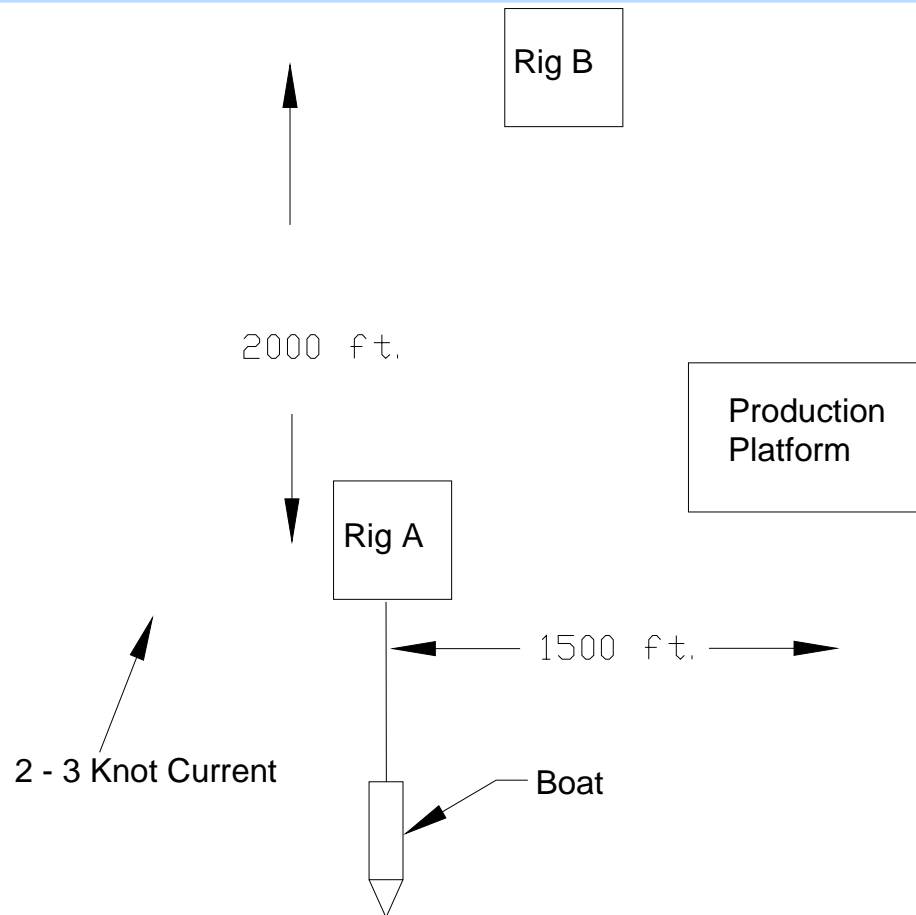
Rig and Boat Configuration for Safety Towing

- Dynamically positioned Rig A is drilling 1500 feet from a Production Platform and 2000 feet from Rig B
- Both rigs are drilling relief well for blowout with platform on fire
- Current approximately 2 – 3 knots from the indicated direction
- In the event of a blackout the rig would rapidly drift into the rig and/or platform **BIG PROBLEM**
- Boat is attached with towing bridle to the rig so that in the event of a rig power loss it can tow the rig to a safe position.
