DYNAMIC POSITIONING CONFERENCE
September 17-18, 2002

Dynamic Positioning Incidents
Resulting From Inadequate Power Systems Analysis

Don E. Wilkes, P.E.

GlobalSantaFe Corporation (Houston, Texas)

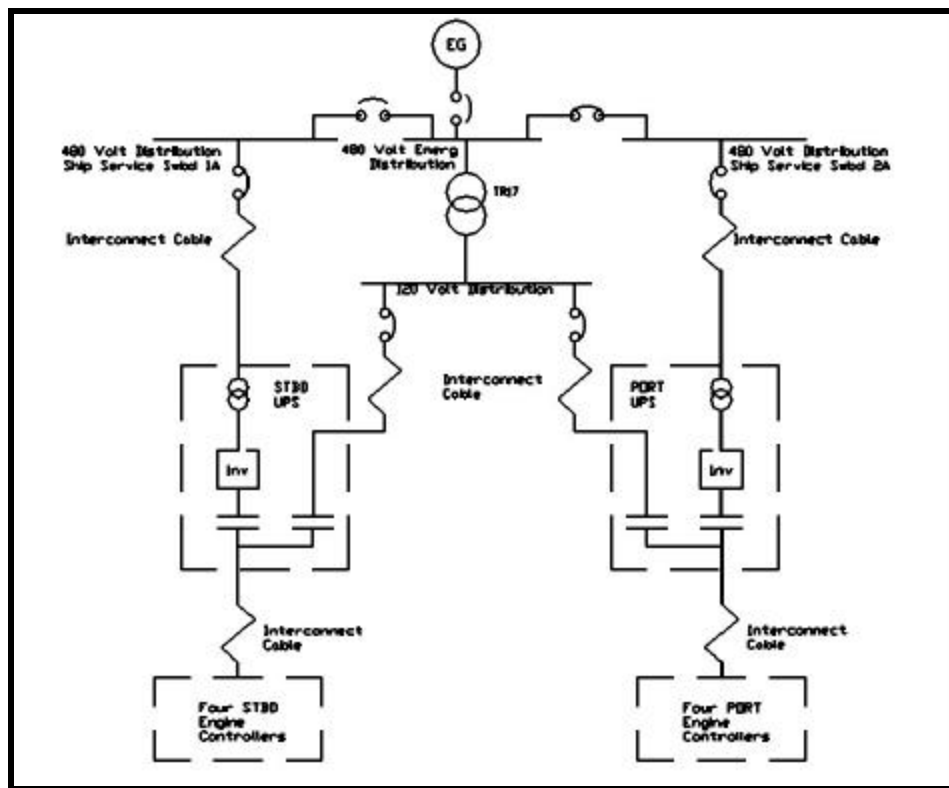
Figure 2

Another example is an occurrence I also discussed last year. That particular problem occurred as a result of multiple failures, but ultimately because of the engine protection system. A simplified block diagram is shown in Figure 2.

The UPS's had both failed and were operating in Bypass mode, supplied from alternate emergency distribution. During a routine weekly test of the emergency generator the emergency distribution tripped off and controls for the engines shut off the propulsion loads for the entire ship. This susceptibility was not identified in reviews prior to the event.

The power sources, protection and support systems must always be included in a failure mode analysis.

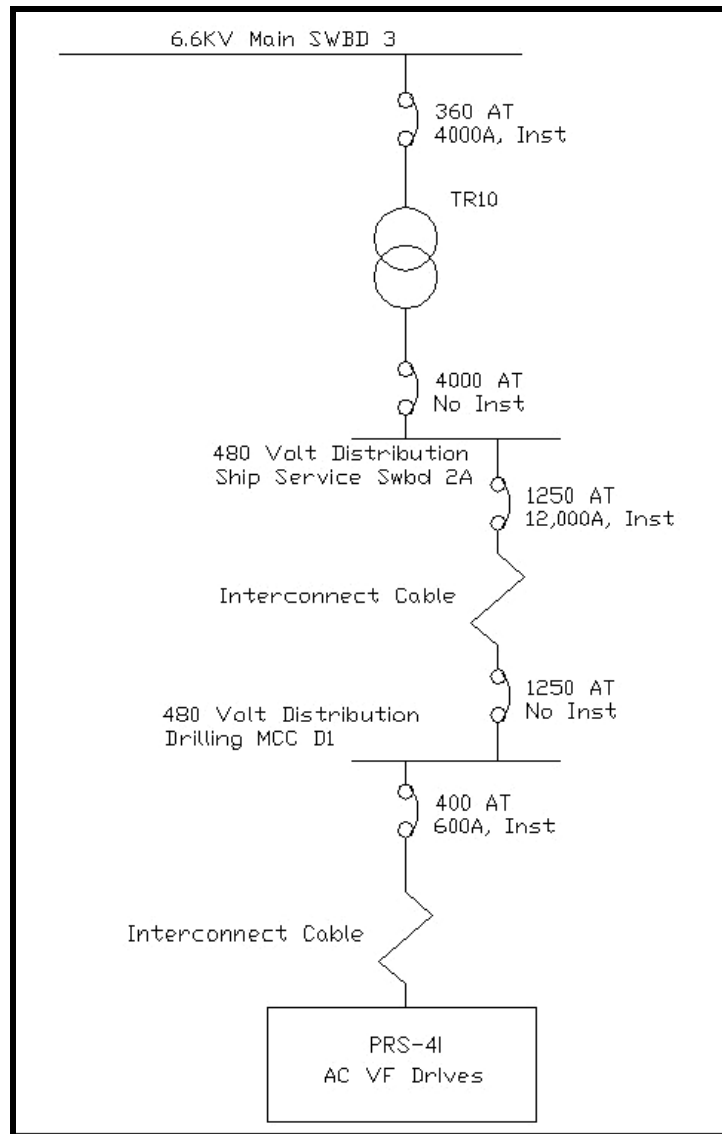
Figure 3 is a portion of the distribution one line that includes equipment involved in another incident. In this event a short circuit fault in the Drill Floor Pipe Racker resulted in tripping of the entire MCC that was supplying about 25% of the drilling equipment. Although the position keeping equipment was not a part of this power loss, one mud pump was lost, which could impact well control capability in critical situations. And there are similar circuits for other equipment that would result in loss of position keeping machinery were a similar fault to occur in those circuits.

Even though power was reestablished in relatively short order, the power system analysis predicted that such a fault should have been limited to that specific load involved in the fault. There is an ABS regulation that requires that faults be cleared by tripping of the nearest upstream circuit breaker.

The 400 Amp circuit breaker feeding the pipe racker included an Instantaneous trip set to about 600 Amps, and the feeder circuit breakers on both ends of the interconnect cable from aft to forward were 1250 Amp circuit breakers, and only one of them had its instantaneous trip enabled, at about 12,000 Amps. Which breakers tripped?

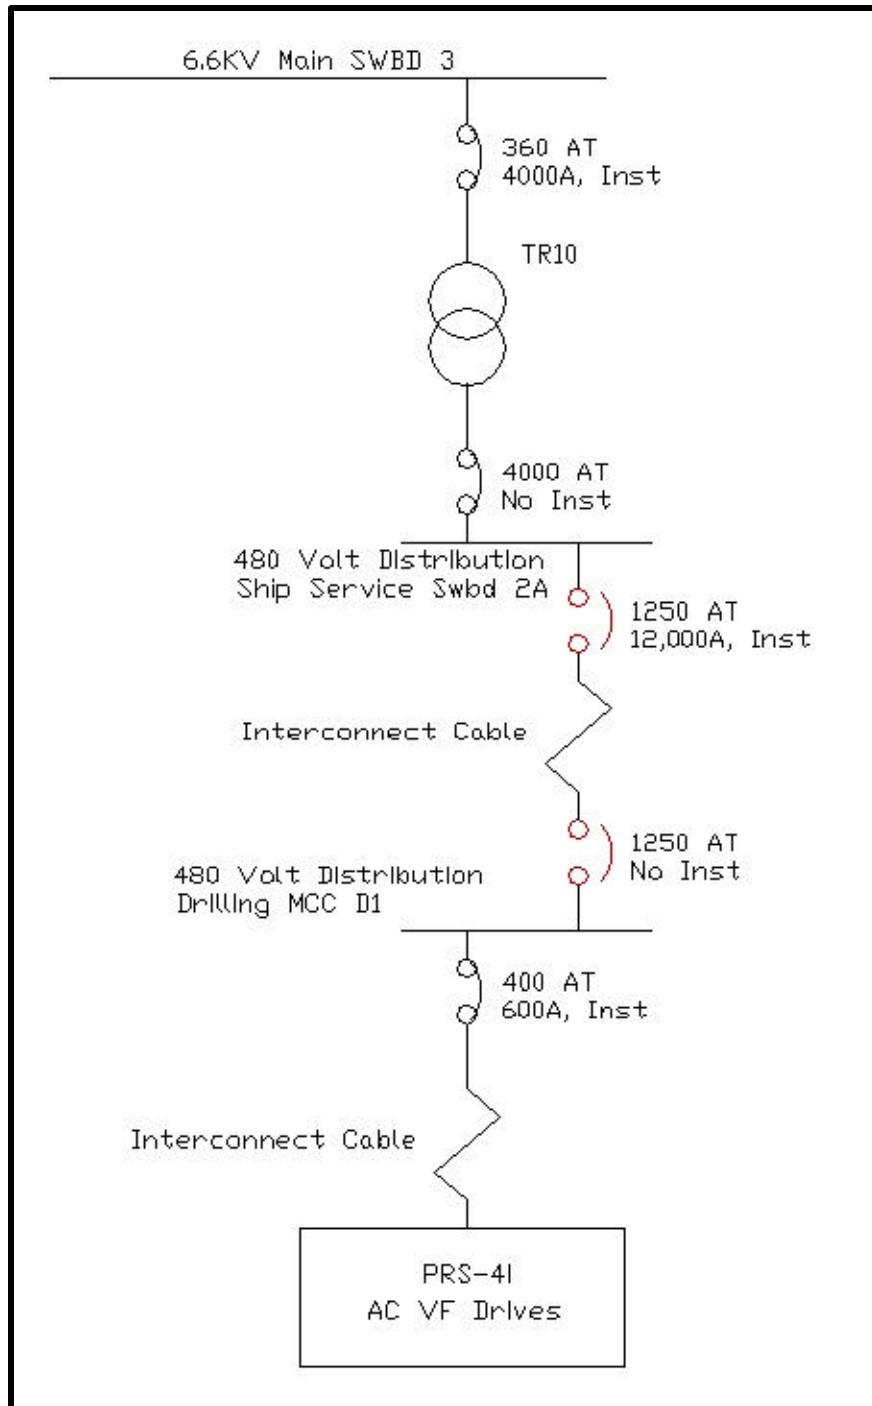
Figure 4

The answer may seem surprising – both 1250 Amp breakers, as highlighted in Figure 4. The 400 Amp breaker remained closed. When the supply breakers were reclosed while attempting to restore power, the 400 Amp breaker did not trip! How could two 1250 Amp circuit breakers trip, one of which even had its instantaneous trip element switched off, and a 400 Amp breaker with a 600 Amp instantaneous trip remain closed? The cause of this problem will be discussed later.

In the example described above, both the 1250 Amp Breakers and the 400 Amp breaker were current limiting but different models. The 400 Amp breaker remained closed and both 1250 Amp breakers tripped, likely because they were different models of breaker with different characteristics of the predictive trips.

When a distribution system incorporates breakers that are activated by the di/dt current prediction methods, additional techniques must be employed to establish the selectivity of the breakers in the various distribution systems. In many cases the necessary selectivity cannot be established when these breakers are used.

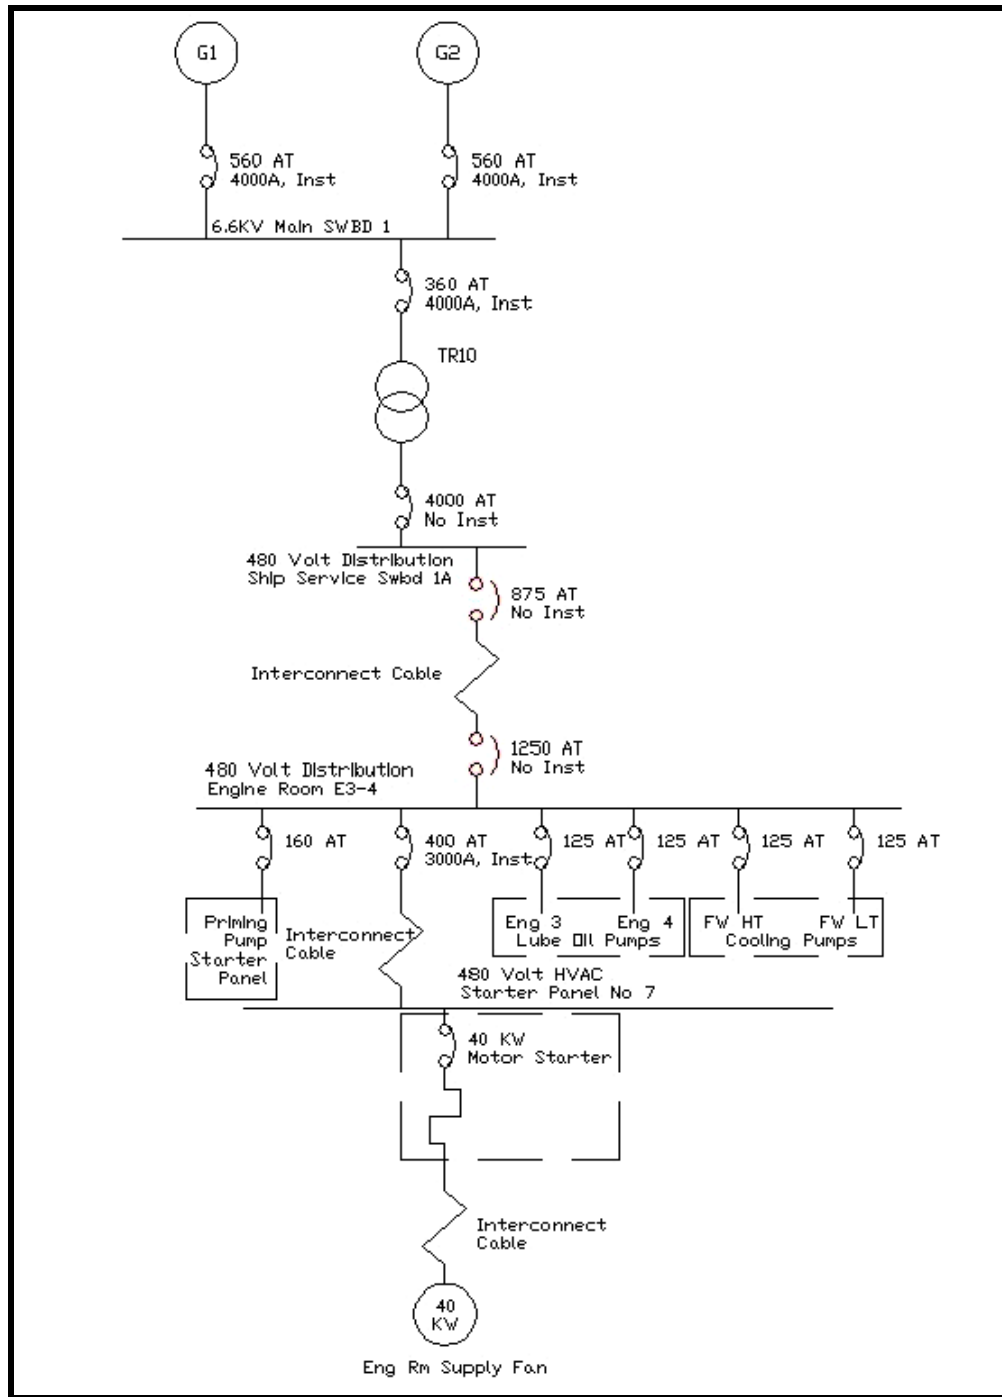
Figure 5 is another portion of the distribution on the same ship. In this segment of the distribution, there are two distribution boards that are sub-feeders from the main Ship Service LV Switchboard. Note also that E3-4 is the engine room distribution board that supplies auxiliary equipment specific to Engines 3 and 4, along with some of the auxiliary systems for all of the Starboard engines. It is supplied from the main LV switchboard through an 875 Amp circuit breaker that did not have an instantaneous trip enabled. A 400 Amp circuit breaker in E3-4 supplies an HVAC distribution MCC that operates one of the Engine Room fans. The fan happens to be a 40 KW two speed fan. Most of the time this fan is on low speed, but at heavy loads on the engines the speed may be increased to improve heat removal. When this motor

shorted, the 875 Amp circuit breaker feeding E3-4 opened and removed the fault from the system. However, at this time only engines 3 and 4 were supplying power to the starboard bus, and when their auxiliaries were shut down the entire starboard side blacked out. All because of a shorted fan motor three levels down in the distribution. Why didn't the motor starter disconnect and prevent the wider blackout? Or why didn't the intermediate 400 Amp breaker trip to protect the E3-4 Distribution board? Initial investigations showed that the magnetic trip (or short time trip) for this 400 Amp breaker had been cranked to maximum – about 4000 Amps, whereas the drawings reflected a setting of 600 Amps for that trip. With the several loads on that HVAC along with the two speed motor it is apparent that the documentation was in error. The starting current for the motor, especially in high speed, would easily approach 250 to 300 Amps. It was concluded that, during commissioning, this breaker tripped when starting the motor in high speed. The solution was typical for startups – crank it up to where it won't interfere. When the motor was replaced and the trip was set back to the documentation level, it did indeed trip when the motor was started. An intermediate level of about 1200 Amps was selected as the setting. But this still left the question unanswered as to why the motor starter didn't provide adequate protection in the first place. The answer to this question turned out to be the same as the previous problem.

Similarly, the 875 Amp Breaker and the 400 Amp breaker in the third example were different models of current limiting breakers, while the motor starter controls operated on actual currents.

If you look back at Figure 5, another common fault is exemplified. In the particular event in question the resulting blackout in the starboard distribution occurred because the lube oil pumps supplying the engines that were operating were supplied from the distribution board whose supply breaker tripped due to the fault. Note however that the source of power for the board is actually derived from the switchboard fed from Engines 1 and 2. Thus, with the same engine configuration, any fault that caused the tie breaker between the two Stbd HV switchboards to open, power to the board that supplies the operating engine auxiliaries would be lost. A more optimal implementation would have loads supplied by the sources they serve. In this particular instance the fault that might result from such a failure would not create a failure more serious than loss of the full engine room so there was no specification basis to exact a modification from the builder.

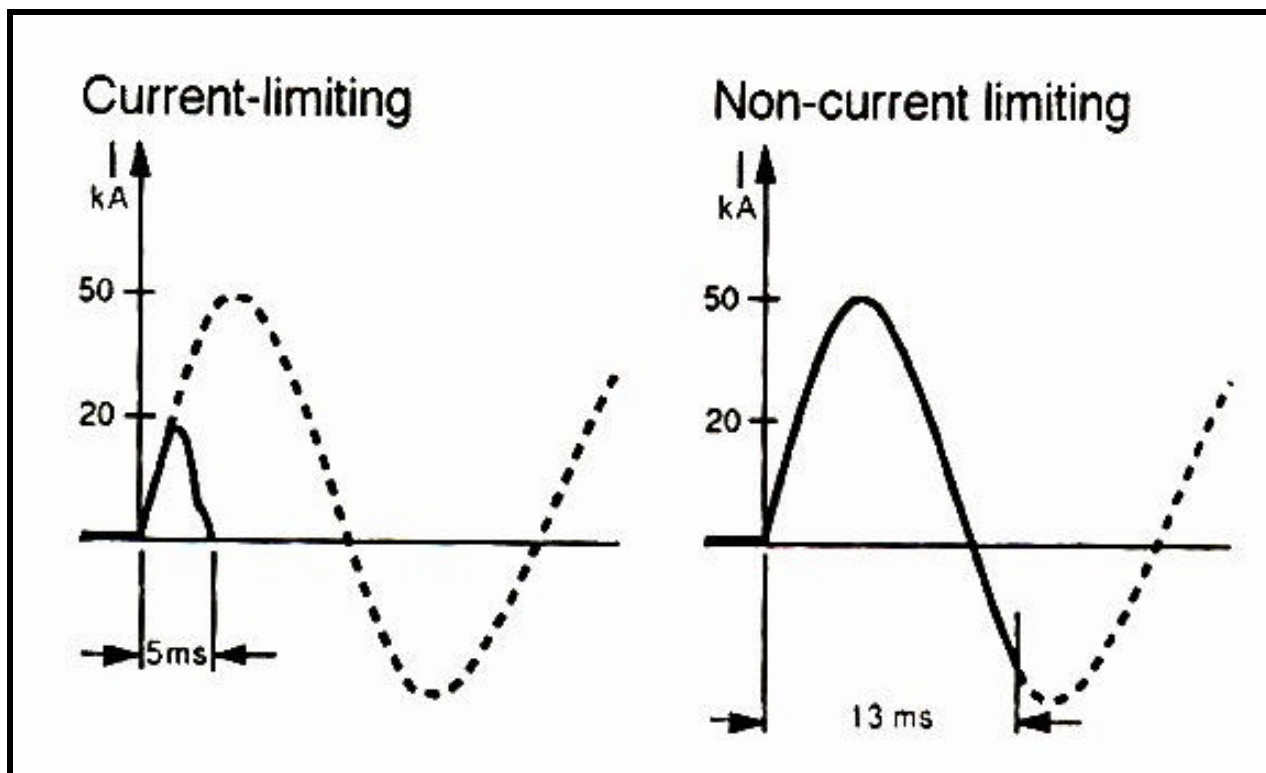
Figure 6

These breakers take advantage of another modern convenience – computer power, along with fast operating mechanisms. Using fast processing, the current waveform is continuously monitored and the rate of change of the current (di/dt) is calculated, providing sub-cycle control of the mechanism. A fault current of 75,000 Amps may have a peak value approaching 200,000 Amps, including asymmetrical components or DC offsets. If the di/dt for the current waveform indicates the current might reach these high values, the breaker is tripped very quickly – long before it reaches these destructive levels. Thus in the presence of high fault currents, these breakers WILL open in five or ten milliseconds.

This trip characteristic is present whether or not the Instantaneous trip function is enabled. It MUST trip in this manner, because it cannot interrupt the high currents that would occur in the presence of a major fault just a few milliseconds later. This allows the smaller breakers to be used in applications requiring high fault capabilities.

Because a breaker employing current limiting techniques actually opens on the basis of *predicted* current levels, circuit breakers that are in series in the fault circuit will predict the same current level and all are likely to protect themselves by opening their mechanism. Similarly, breakers that are in series fault circuit that do NOT employ the predictive techniques and operate on the *actual* current levels will not trip as a result of the fault because the current limiting breakers will open before the fault level reaches the energy level associated with even an Instantaneous trip characteristic. Even when all breakers may use predictive techniques, different models of breakers may use trip devices that have different predictive techniques. Larger breakers typically have more space available to permit installation of a trip device with more computational power. User expectations may also dictate a more sophisticated trip unit for the insulated case or metal enclosed breakers than for the smaller molded case size circuit breakers.
