Sedco Express DGPS Operations Five Years of Lessons Learned

Lew Weingarth and Stephane Angue

Transocean, Inc.

October 17-18, 2006

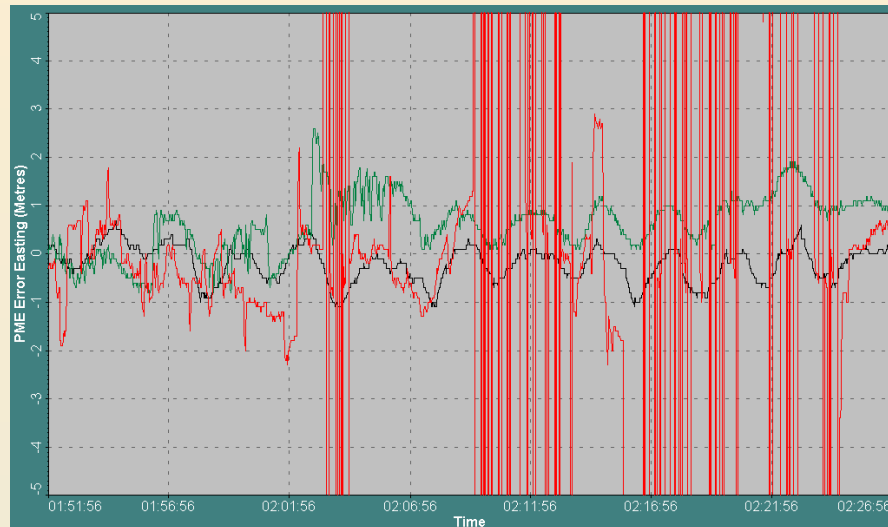
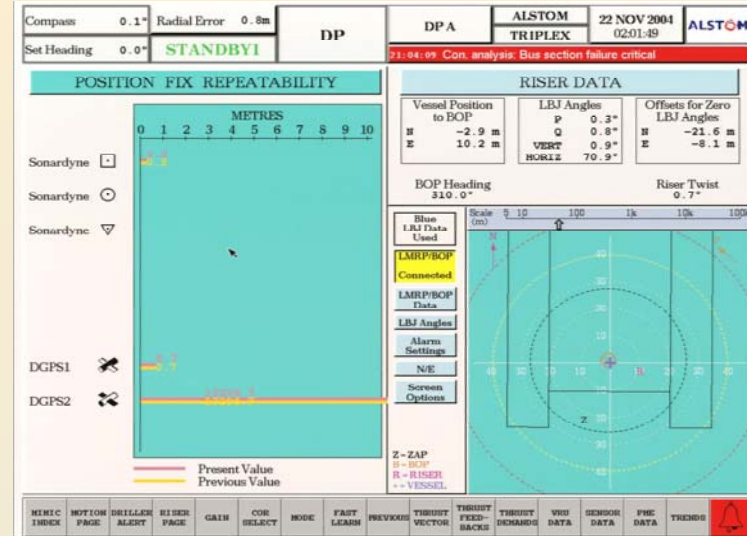
DGPS degraded status – 22/11/2004

- Software failure. Backup solution @ 141km from primary solution. No operator warning.
- Primary solution failing and Trinav switch to backup solution. Rejected by DP (jump of 141km).
- GPS receiver reset to clear the fault.

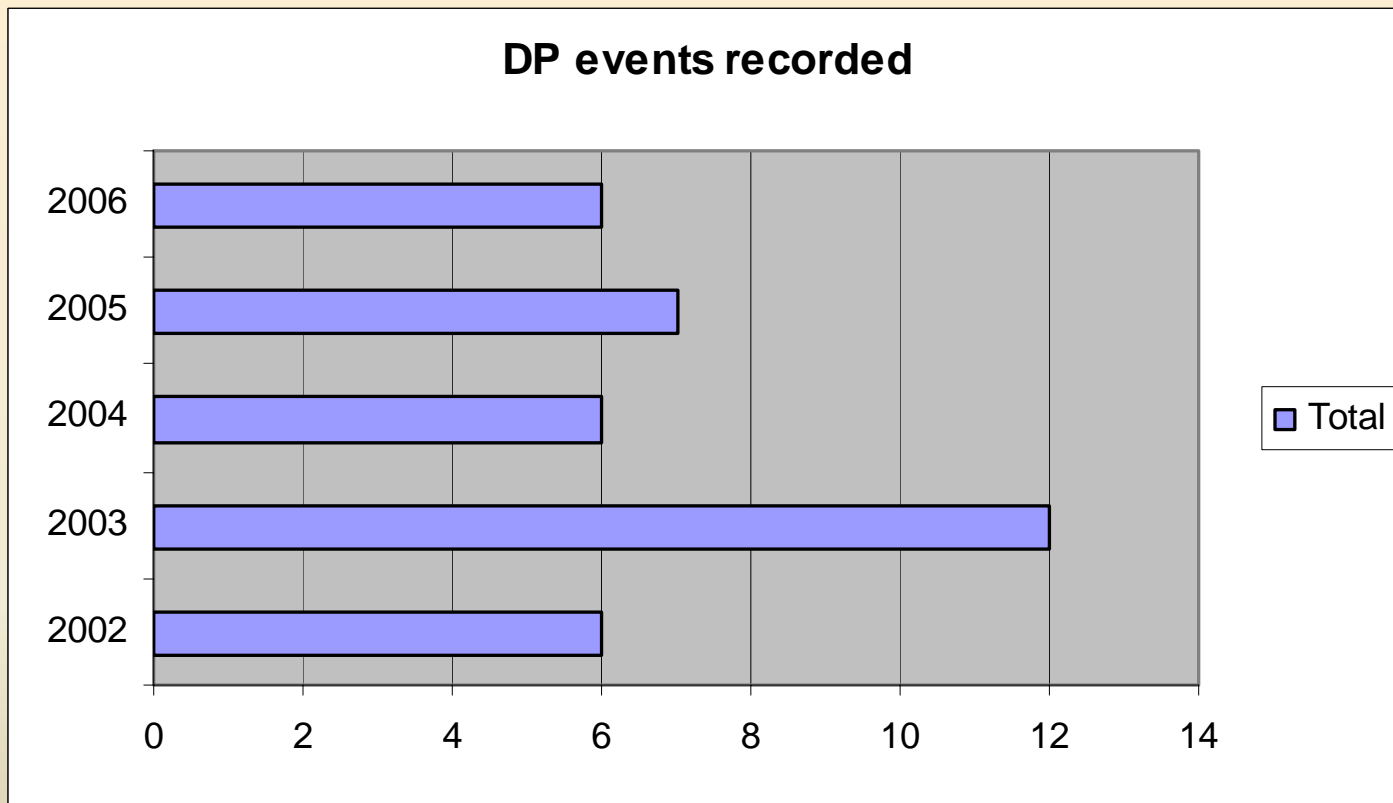
37 Recorded DP events

From January 2002 to October 2006

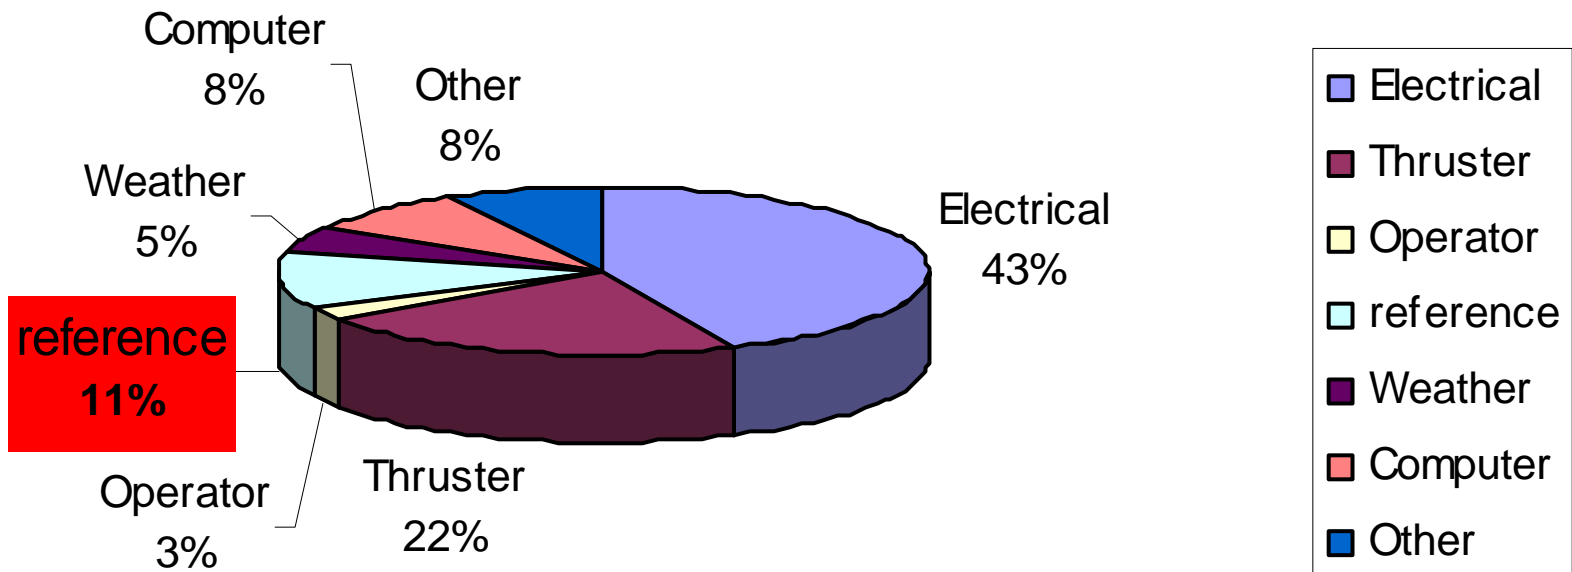
DP events recorded by category

- Around 1500 days of rig operation
- 6 Yellow alert conditions occurred since rig start up. No Red (disconnections) occurred.
- 2 of DGPS system failures led to Yellow alert conditions (33% of total yellow alerts)
- No Recorded event related to DGPS since new system installed

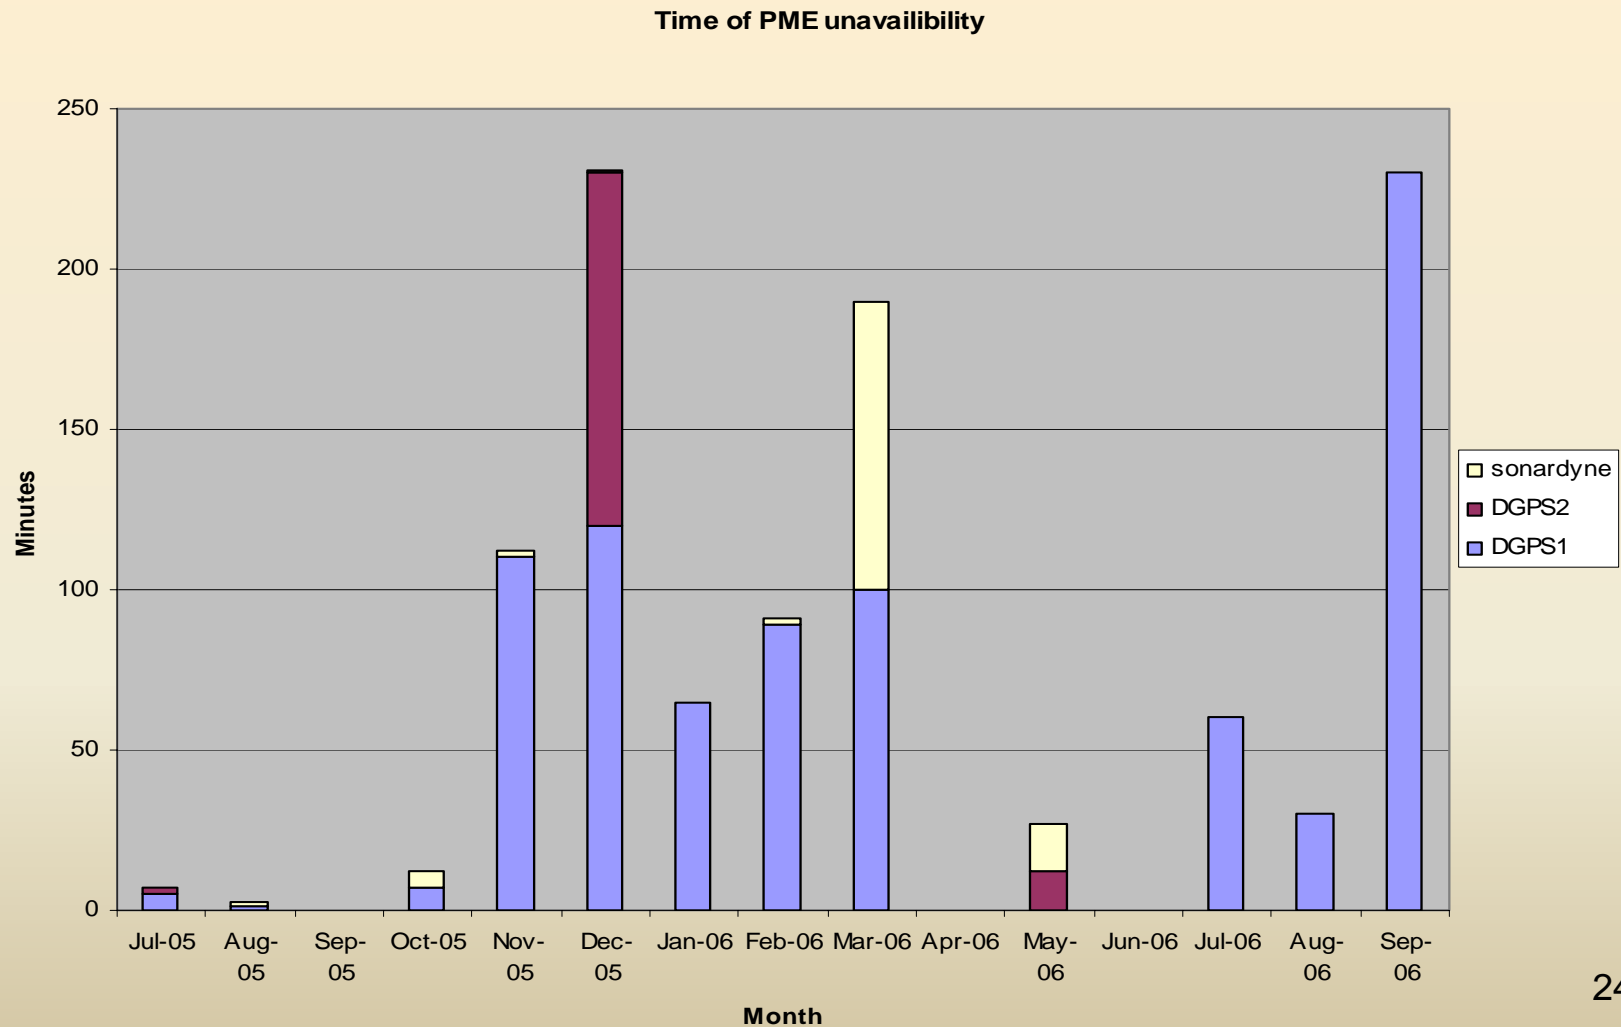
New DGPS system time of unavailability since installation

- Poor reliability of HP solution in Seastar DP (>1200 solution reset in one year)
- Computer failures on reboot process (Seastar DP)
- Software failures (Input/output management software – Seastar DP)
- MRU loss of performance not detected by Multifix software causing position reference rejection in DP
- Software glitch on Multifix 4 (Sunday 0000 GMT bug – negative latency figure)
