DYNAMIC POSITIONING CONFERENCE
September 17-18, 2002

Dynamic Positioning Incidents
Resulting From Inadequate Power Systems Analysis

Don E. Wilkes, P.E.

GlobalSantaFe Corporation (Houston, Texas)

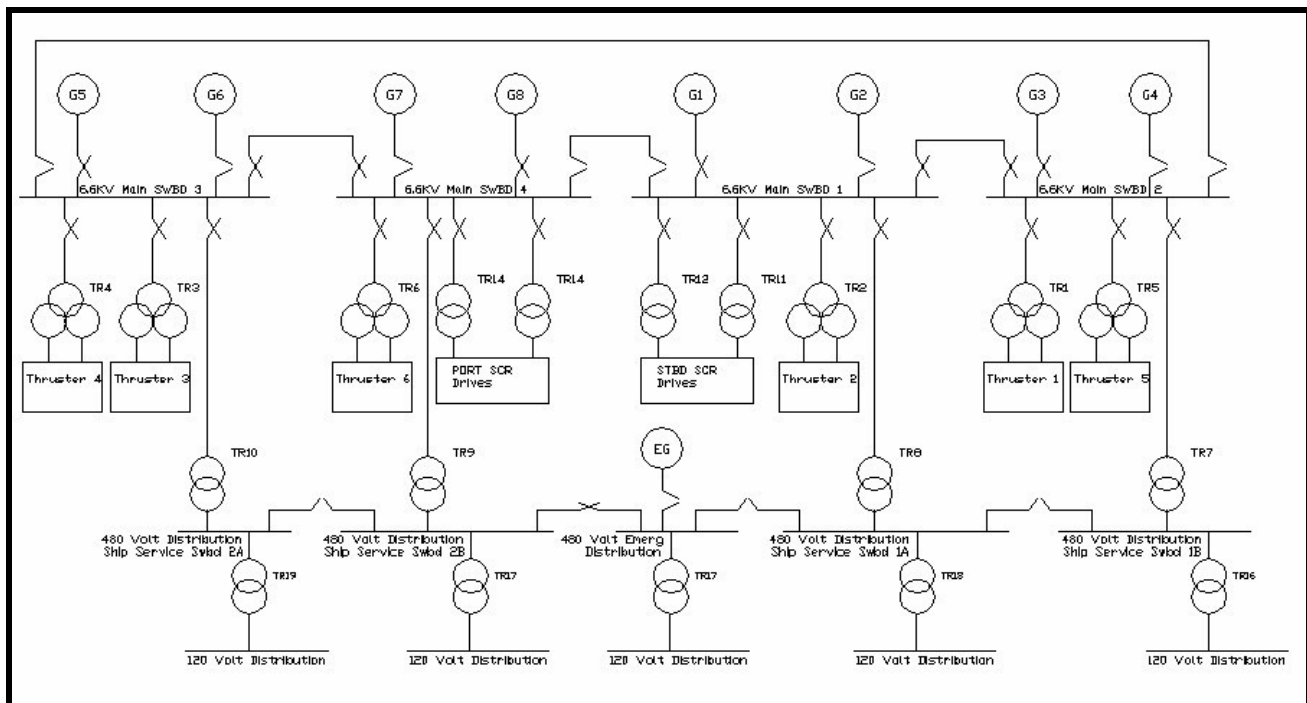
Figure 1

Note that there are four separate systems that may be operated individually or in a variety of combinations of these buses. An Emergency generator is also a part of low voltage distribution system. Details of the distribution are too complex to be incorporated here, but there are some features that deserve comment. The vessel has been classed as a DPS-3 vessel, arranged as two main engine rooms with auxiliary systems and propulsion systems arranged to support a dual power system arrangement. For this vessel typical operation is as a split power system with two HV busses but four LV busses to provide what is considered to be maximum reliability.
