Sedco Express DGPS Operations Five Years of Lessons Learned

Lew Weingarth and Stephane Angue

Transocean, Inc.

October 17-18, 2006

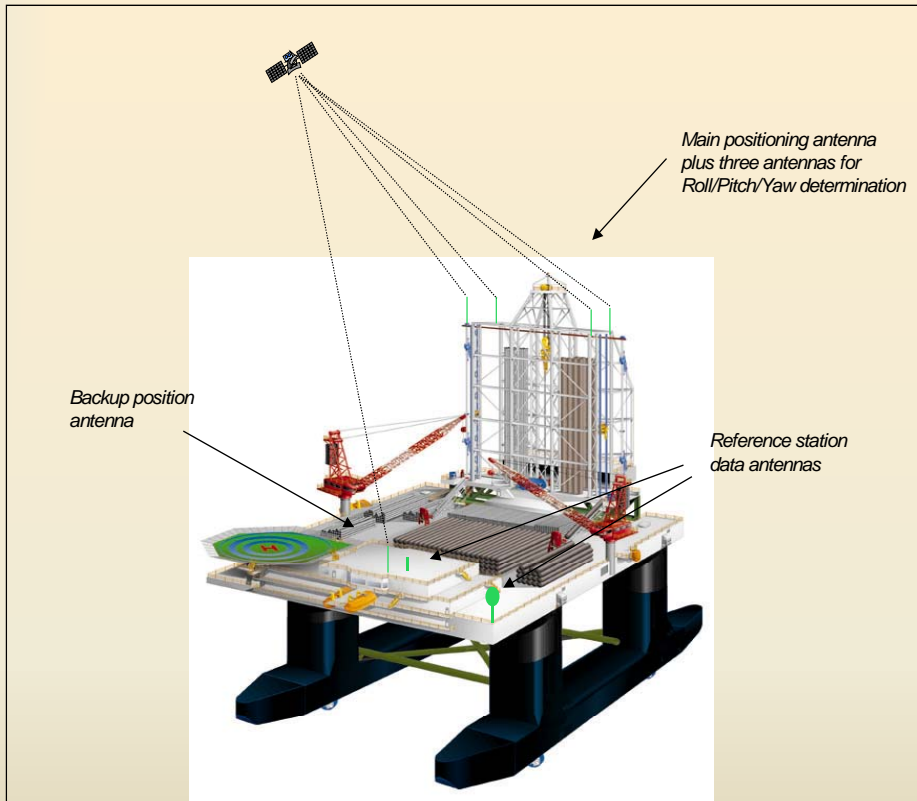
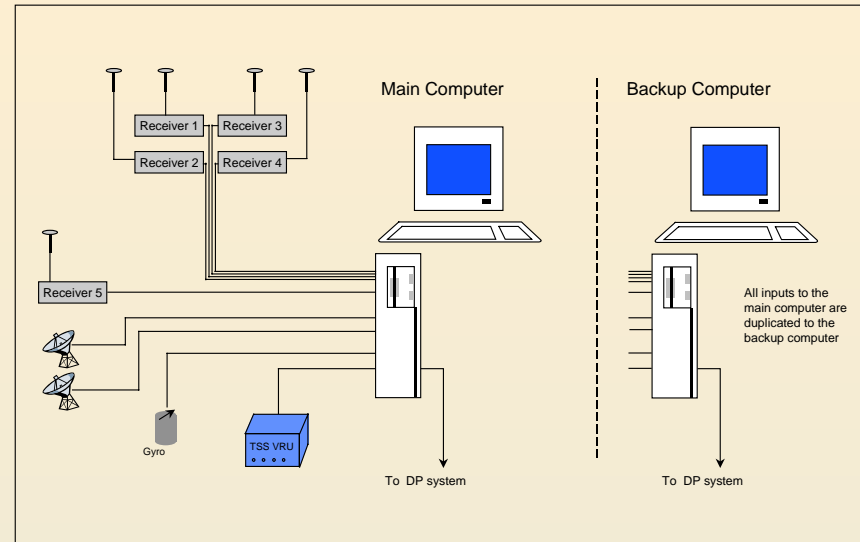
Former DGPS system - TRINAV

ADVANTAGES	DISADVANTAGES
•Simple man machine interface	•Obsolete (poor Dual frequency performances)
•Good internal redundancy (GPS receiver and differential links)	•Poor performance during scintillation period
•1 GPS receiver+ 1 differential link installed on bridge mast	•No quality control except the DQI parameter
•HF link correction available	•Same software on both system
•DPO / ET system experience	•Multiple GPS receiver failures or loss of performances
•Spare parts available on board	•RTCM link hardware failures
	•Unix O/S
	•Software failures and bugs
	•No remote control from backup room system

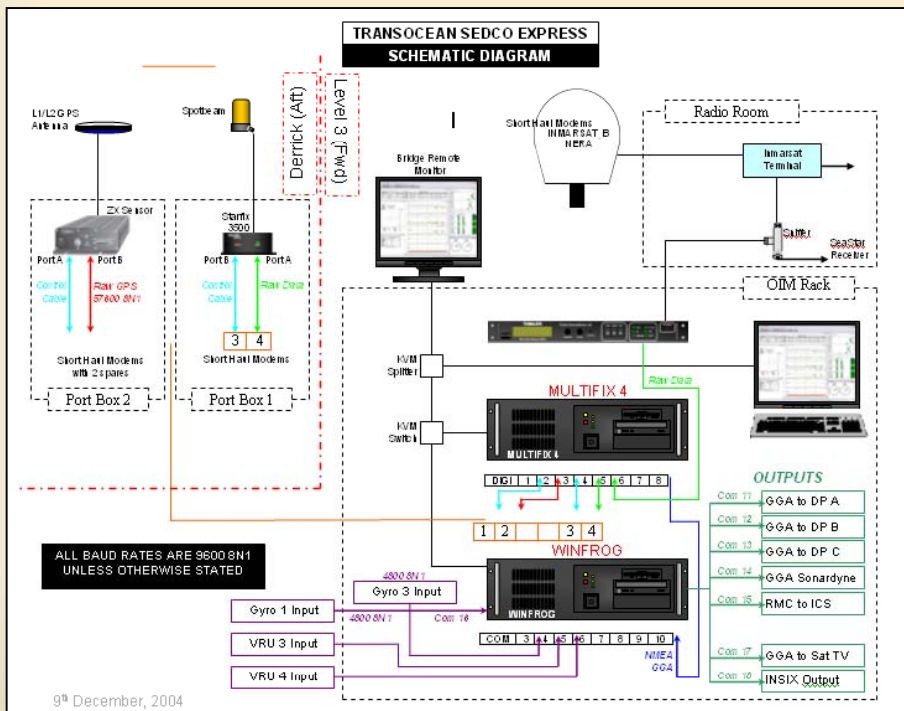
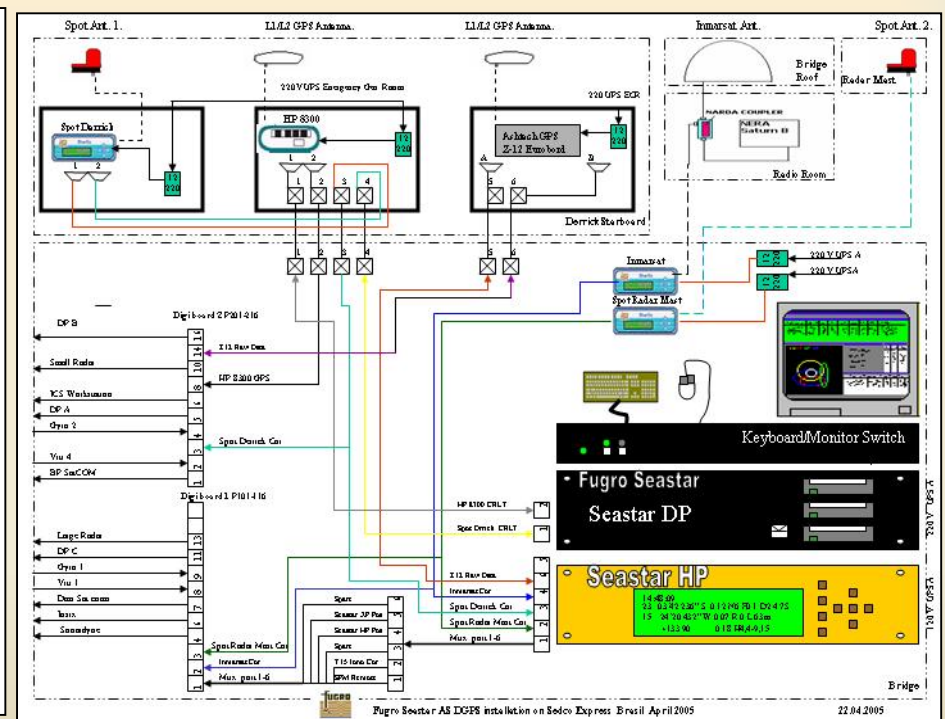
Multifix-Winfrog / Seastar DP

- Poor reliability of HP solution in Seastar DP (>1200 solution reset in one year)
- Computer failures on reboot process (Seastar DP)
- Software failures (Input/output management software – Seastar DP)
- MRU loss of performance not detected by Multifix software causing position reference rejection in DP
- Software glitch on Multifix 4 (Sunday 0000 GMT bug – negative latency figure)
