DYNAMIC POSITIONING CONFERENCE

Analyzing Petrobras DP Incidents

Marcelo Santa Rosa Costa
Petrobras

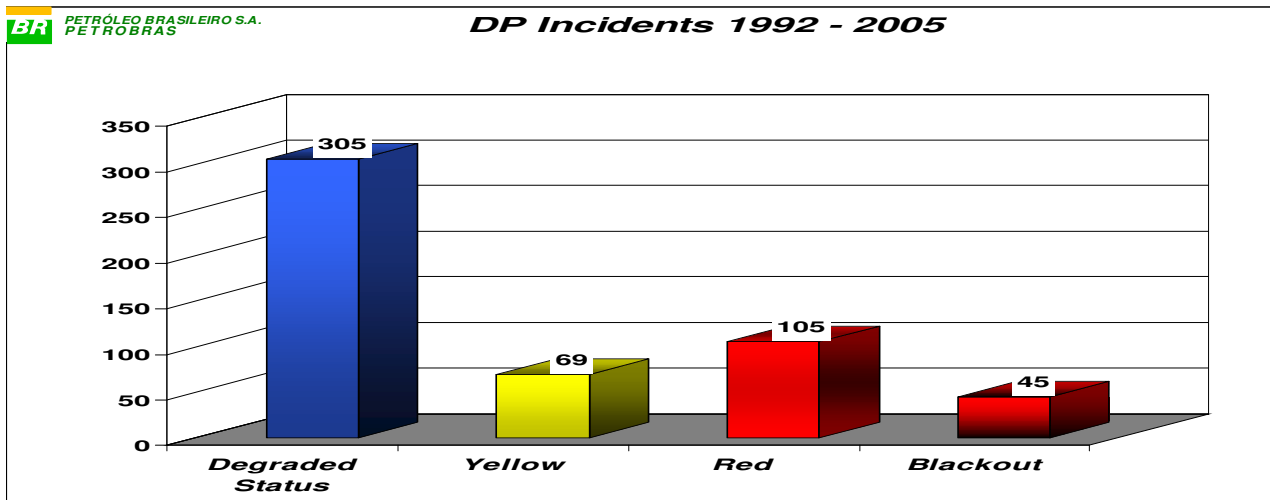
The next graphs present the incidents in the period after DPPS has been created. That was characterized for having more precise data being gathered from newly born standards that allowed us to make deeper analyses and to search for root causes in a much easier way. Within the period from 1992 to 1995 we had 479 incidents in total, according to that classification previously defined, and the graph below shows how incidents were distributed. The amount of 45 Black Out situations is shown only as extra information and it is included on the total of Red & Yellow alarms. Due to the time available for the presentation no further analysis will be made for Yellow Alarm Status.

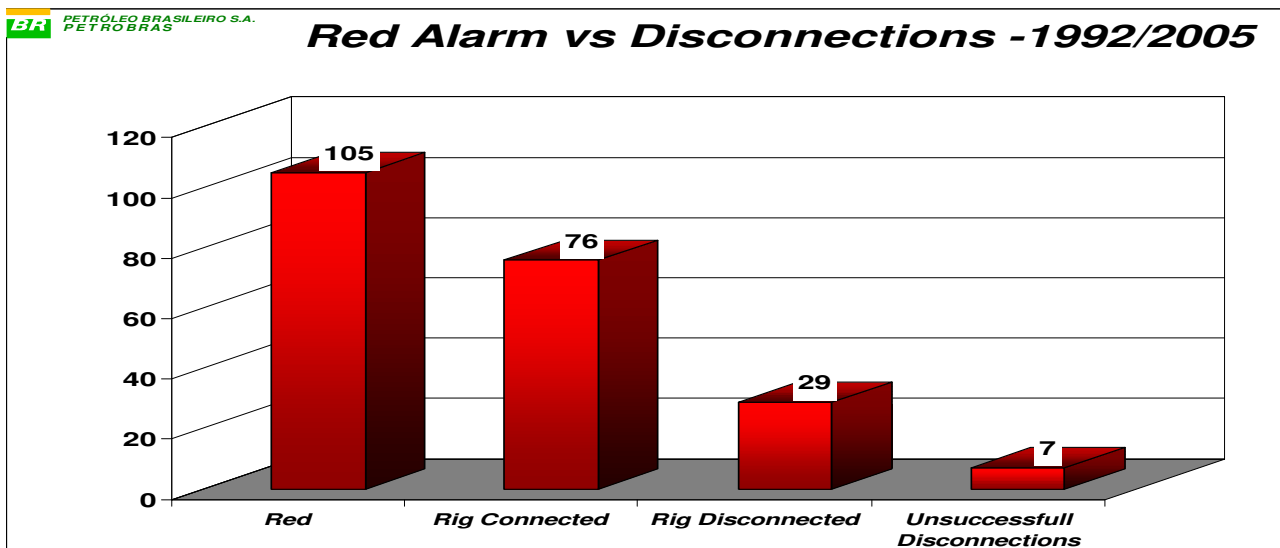
By comparing the number of Red Alarm Status with the number of Disconnections, we can evaluate how critical was the incident. By far, the vessel was connected when the Red Alarm went off: 76 of 105 times. In another 29 times the red light came up but the vessel was not connected. From the total, we had 7 failed attempts to disconnect. It was due to wrong disconnection procedures or because the emergency disconnection sequence has failed.

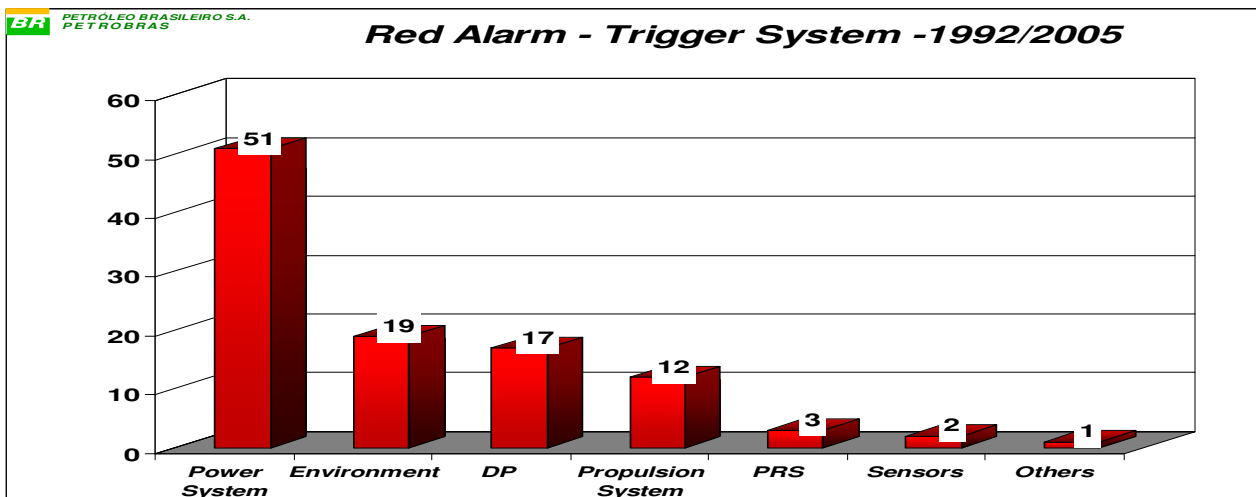
From 1992 to 2005, when considering the number of Red Alarms from the Trigger System's point of view, we found that the Power System was by far the main source of reports: 51 of 105.

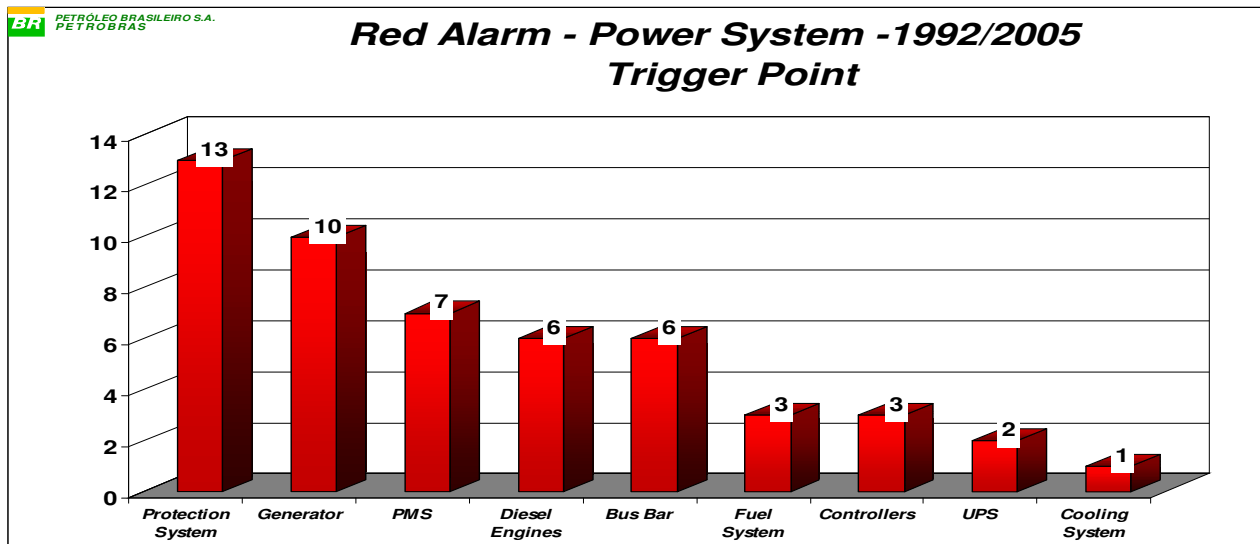
Going deeper with that analysis we noted that the Protection System, which includes not only the protective devices but also the Coordination & Selectivity Survey and its (wrong) calibration, was responsible for 13 reports followed by the Generators with 10 related incidents.

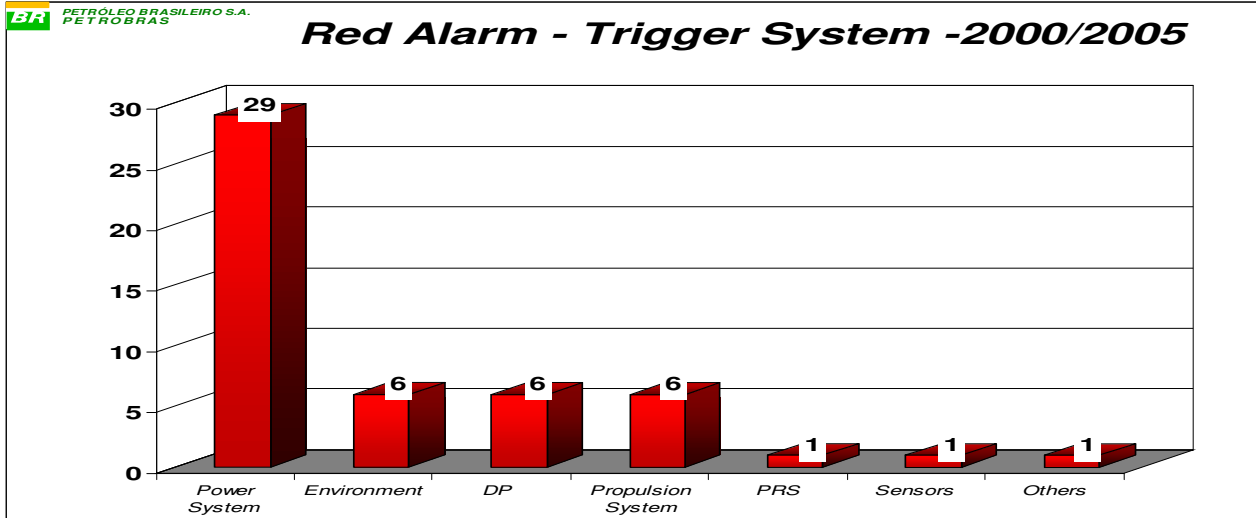
We got almost the same result when our focus is on the period from 2000 to 2005: 29 of 50 incidents were triggered by the Power System. No surprises since many vessels have been modified or upgraded in a hurry.

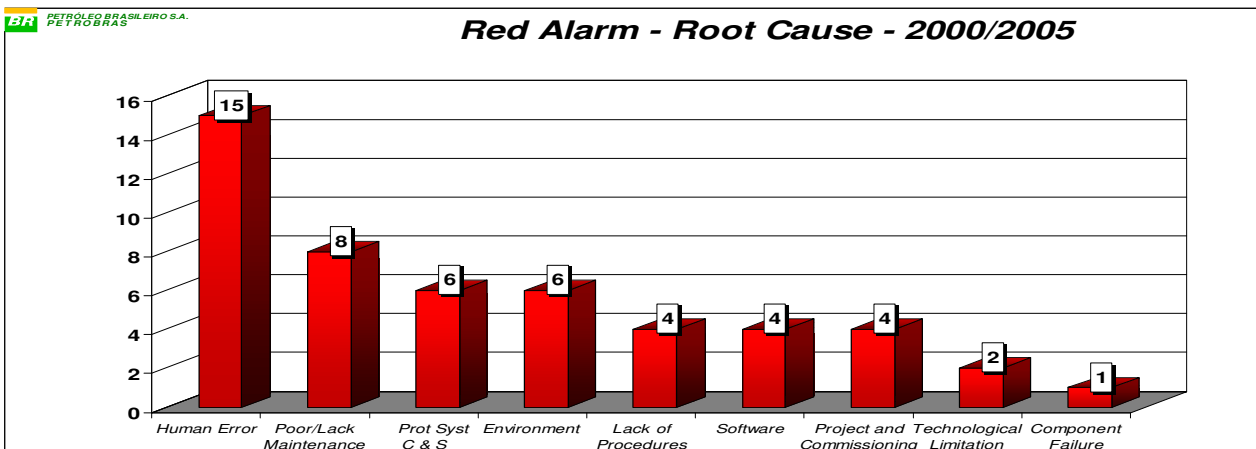
Analyzing the total of 50 incidents on this period we also verified that human error was the Root Cause in 15 of them, which corresponds to 30% of the causes and demonstrates a relatively larger number compared to the second period.

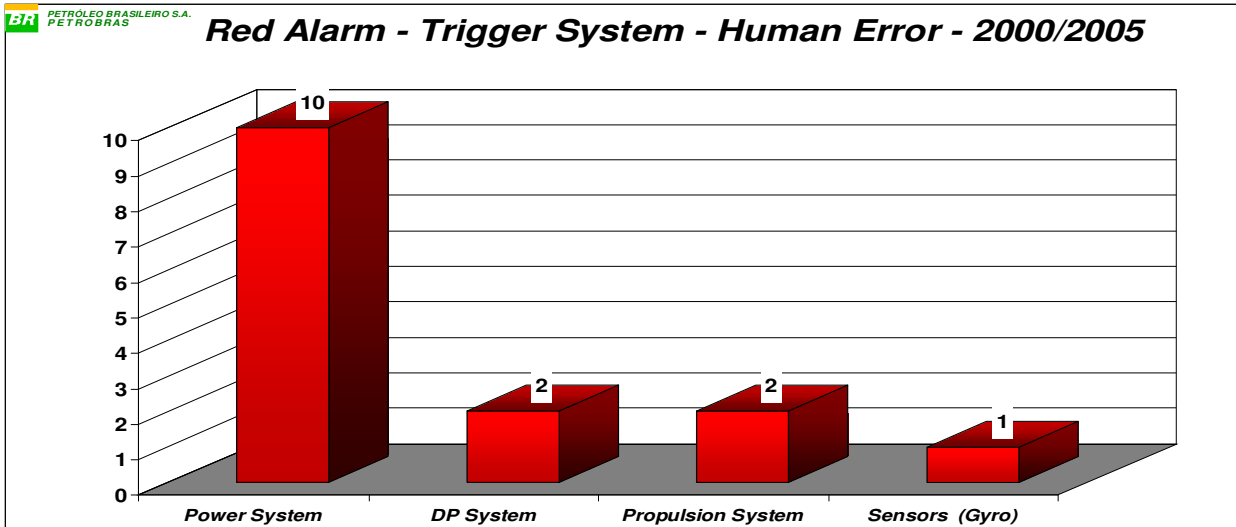
From those 15 incidents reported, 10 were related to the Power System while 2 were related to the DP System, 2 to the Propulsion System and 1 was related to Sensors (Gyro).

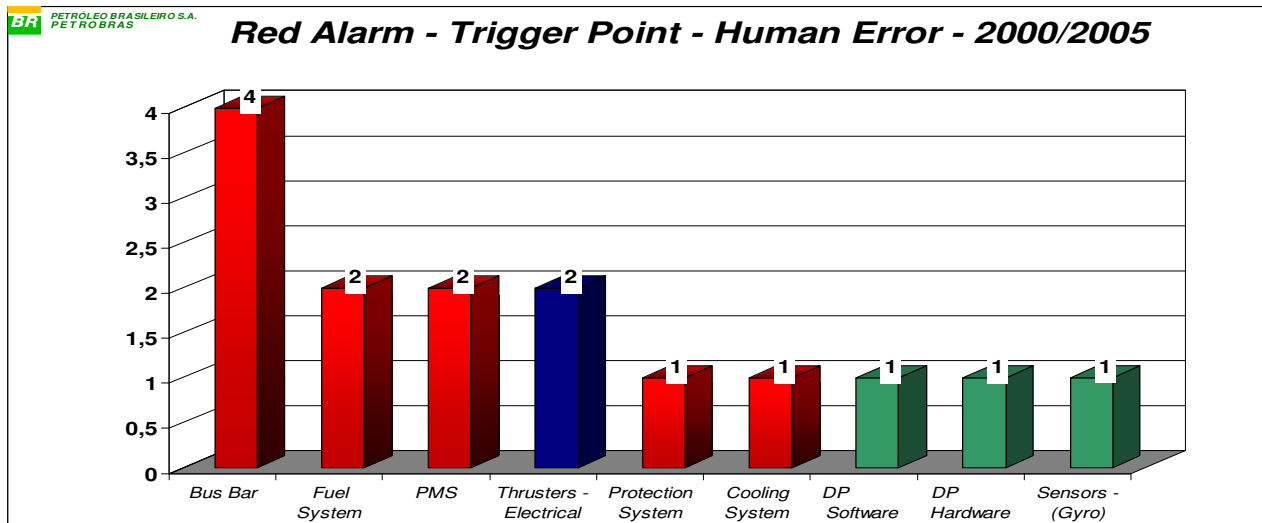
Going deeper on this analysis we got that the related trigger points were: Bus Bar (4), PMS (2), Fuel System (2), Thruster/Electrical (2), Protection Devices (1), Cooling System (1), DP Software (1), DP Hardware (1) and Sensors – Gyro (1).

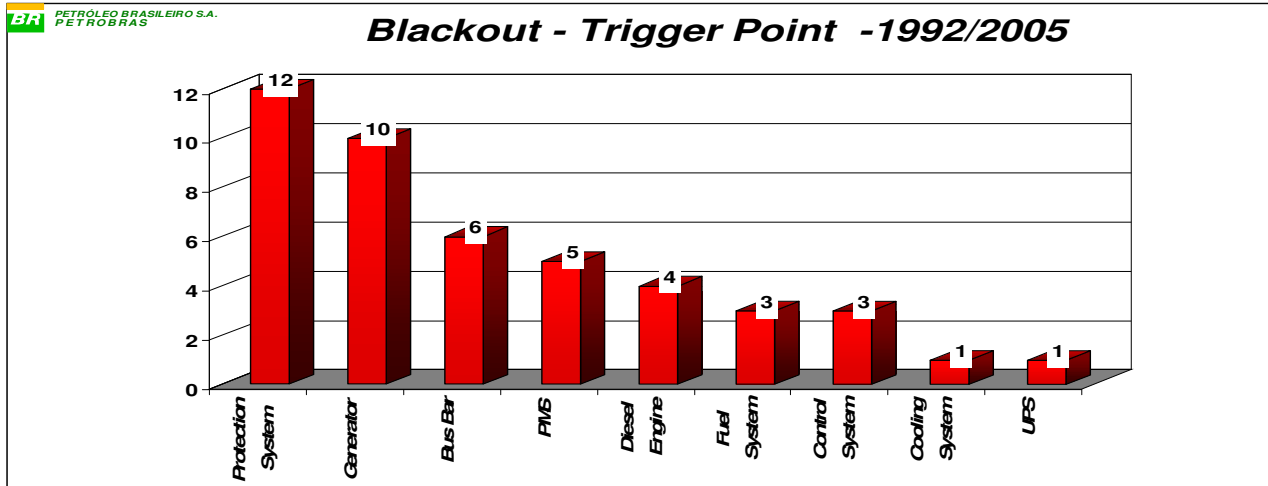
Another important scenario is related to the incidents that led to blackouts where, naturally, the main source is the Power System. From a total of 45 blackouts reported between 1992 and 2005, 12 were triggered by Protective Devices, close followed by the Generators with 10 occurrences. The other important reports were related to Bus Bar (6), PMS (5), Diesel Engines (4), Fuel System (3), Control System (3), Cooling System (1) and UPS (1).

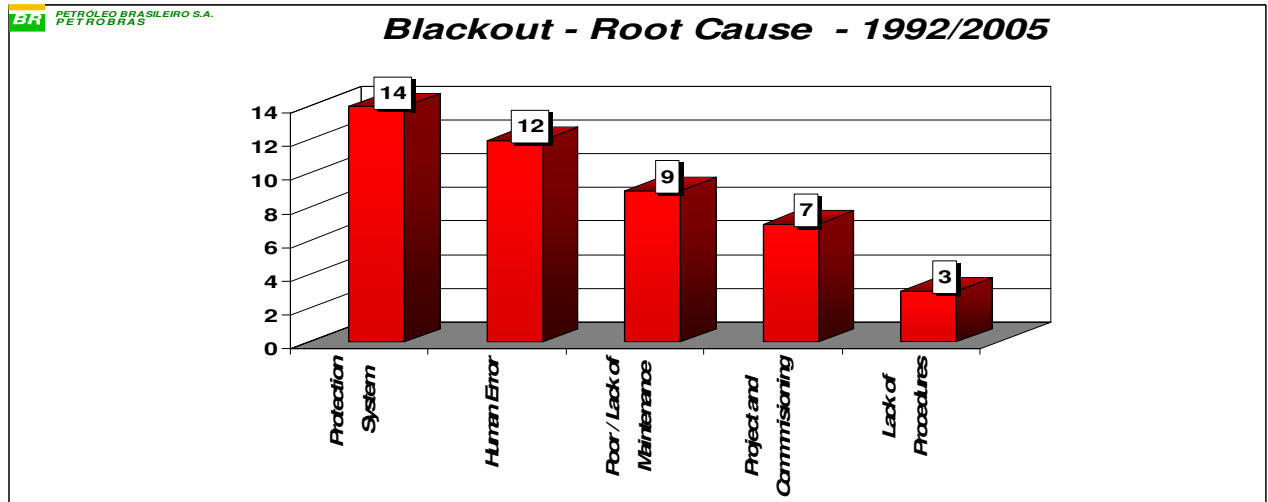
When considering the root cause of incidents in that period we found that 14 out of 45 were triggered by the Protection System while 12 were by Human Error, 9 by Poor/Lack of Maintenance, 7 by Project and Commissioning and 3 by Lack of Procedure.

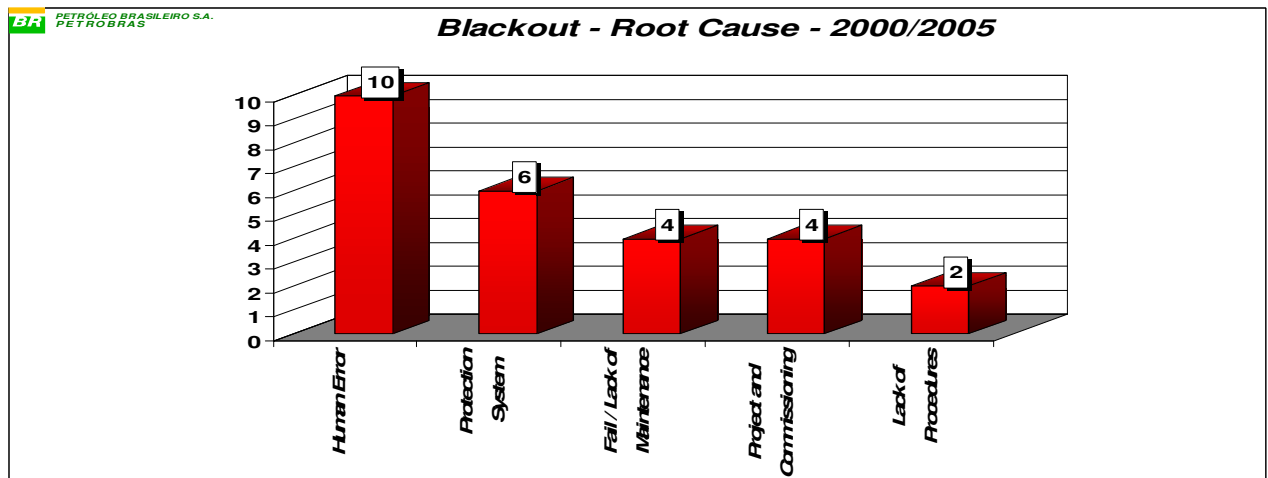
The scenario looks different when we focus the period of time between 2000 and 2005 where Human Error was the trigger point that most appeared: 10 times out of 26. The Protection System with 6 events, Poor/Lack of Maintenance with 4, Project and Commissioning with 4 and Lack of Procedure with 2 filled the whole picture.
