DYNAMIC POSITIONING CONFERENCE
September 18-19, 2001

DP OPERATIONS SESSION

**DP Bow Thruster Noise Remediation
in ROGER REVELLE, AGOR-24**

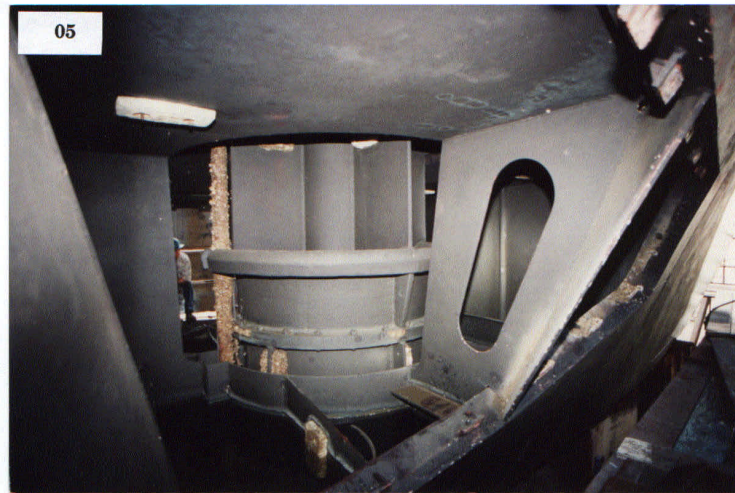
Figure 2: Thruster Sea Chest (ATLANTIS)

axis, 50 inch diameter duct bore. Thrust is azimuthally directed by a rotatable discharge deflector-louver at the keel. The thruster takes suction from a submerged sea chest compartment, Figure 2, fed through large gridded intakes that are symmetric, port and starboard. The thruster is located on centerline at frame 19.

For ATLANTIS, a major effort was made to decouple the sound-energized water in the thruster sea chest from its bounding structure. To this end, the interior surfaces of the sea chest compartment were covered with a compliant, closed-cell foam-rubber decoupling material. To reduce internal transmission, the structure was extensively treated with vibration damping material. In addition, a less heroic effort was made to reduce the cavitation source strength by several means. These included enlarging the gridded intakes to reduce water velocities and pressure drops, adding grids to the thruster bell-mouth to break up suspected suction vortexes, increasing the lateral clearances between the thruster suction bell-mouth and adjacent web frames, and introducing air to the thruster intake to cushion the collapse of cavitation bubbles in the propeller.

While not appearing critical, it was decided to remove the angled plates at the mid-point between the grids (visible in Figure 2 and in Figure 4b) as an obvious source of blockage, hence wake in the thruster inflow. These angled plates were probably originally placed to keep flow out of the sea chest with forward motion of the ship. The web frame at fr. 19 had to be extended outward and fitted with landing pads for the grilles, which were redesigned to suit. All frame and grid members were thereafter more-or-less aligned with the thruster inflow through the molded surface of the hull.

The steering shaft, 3" in diameter, runs vertically just behind the thruster duct, on the centerline of the ship. The barnacle-covered steering shaft is visible in Figure 2. The bellmouth rim is actually cut away to clear it. Close behind is a centerline partial bulkhead. Fairing of this shaft was thought to be important. Our first attempt avoided enclosing the steering shaft while hiding the instrumentation cable tube, which also appeared troublesome, Figure 8.

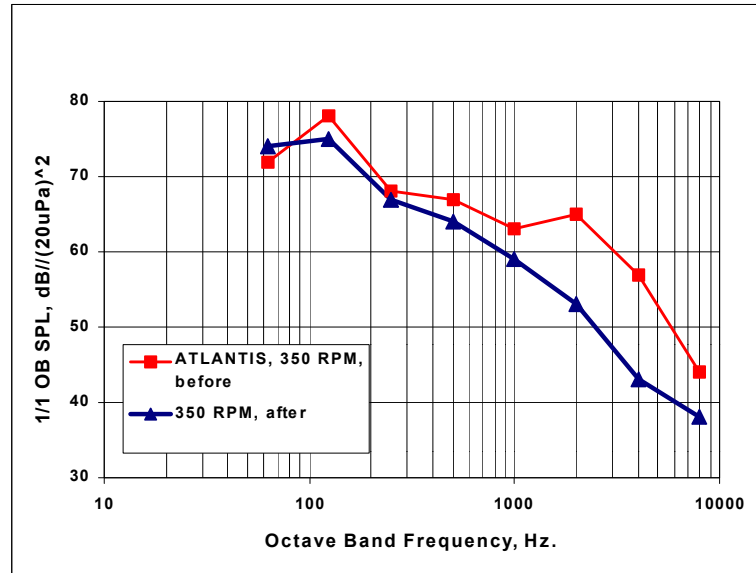
Figure 3: Room 2-22-2, Before and After SPLs, 350 RPM - ATLANTIS

Upon completion and test it was found that the surface treatment and damping did work well – at the higher frequencies, Figure 3. Air injection had a smaller-than-hoped-for benefit, due to limited air supply. The bellmouth grids, intended to kill suction vortexes that were probably absent, probably made things worse by their wakes, and their removal recommended. Effects of intake and clearance enlargements were not resolvable from the noise measurements.

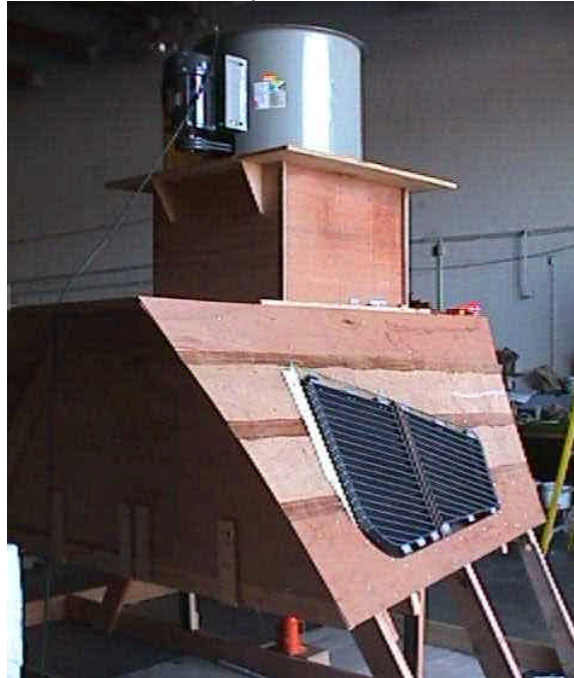
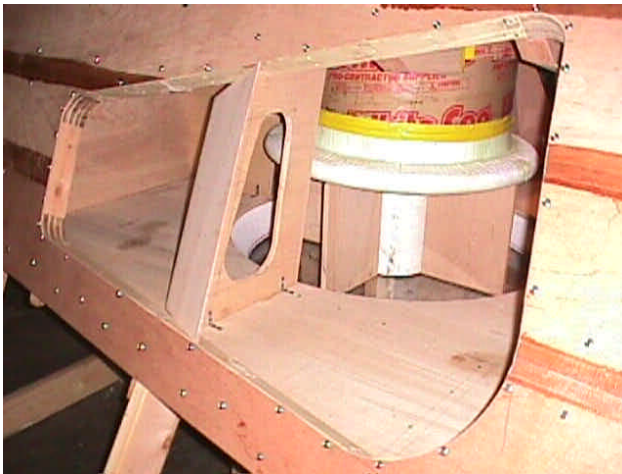
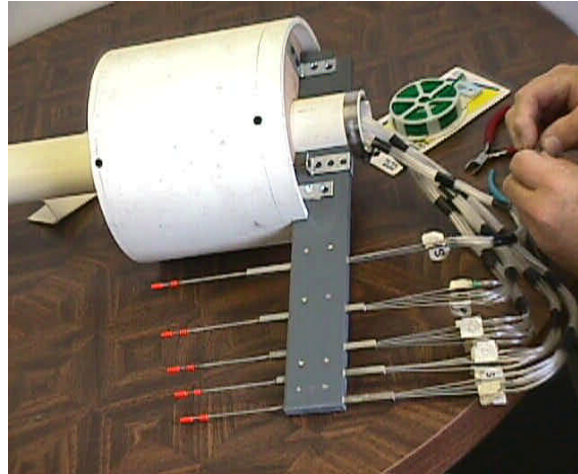
Figure 4: Air Test Model

A detailed mock-up model was constructed of the thruster duct, sea chest, and hull in the vicinity of fr. 19. The model was built at 48% scale because of the availability of 24" ID SonoTube to replicate the 50" thruster duct. The model was built inverted, that is, with keel up, as may be seen in Figure 4a. A tube-axial blower was fitted to take suction at the keel so as to draw air through the model thruster duct from the sea chest and through the gridded intakes in the hull. Construction was of fitted planks of ¼" plywood over beveled frames. The grid models were fabricated of PVC strip. The thruster bell mouth was replicated in Styrofoam, and plate structure in ½" plywood, Figure 4b. A rotatable rake of five, directional Pitot-static probes was installed, the probe tips located along the leading edge locus of the original thruster propeller, Figure 4c. Finally, the overhead of the sea chest compartment was replicated in transparent Plexiglass. A set of small holes in this plate allowed observers, lying underneath the mock-up, to insert slender dowels fitted with wool tufts to observe flow patterns.

The Pitot rake, was rotatable by hand to a number of angular positions. Each "hole" of the probe set was piped to an individual semiconductor pressure transducer. The output voltages of these transducers were sampled and recorded by the OMB data acquisition system on parallel channels. Averages were calculated over selected time intervals; typically 20 seconds in length. Absolute pressures were calculated for each by using no-flow zeros and through-system transducer calibrations of all channels. These pressure numbers were combined to calculate three components of absolute velocity at each position by applying calibration factors which had been measured for each of the Pitot probes.

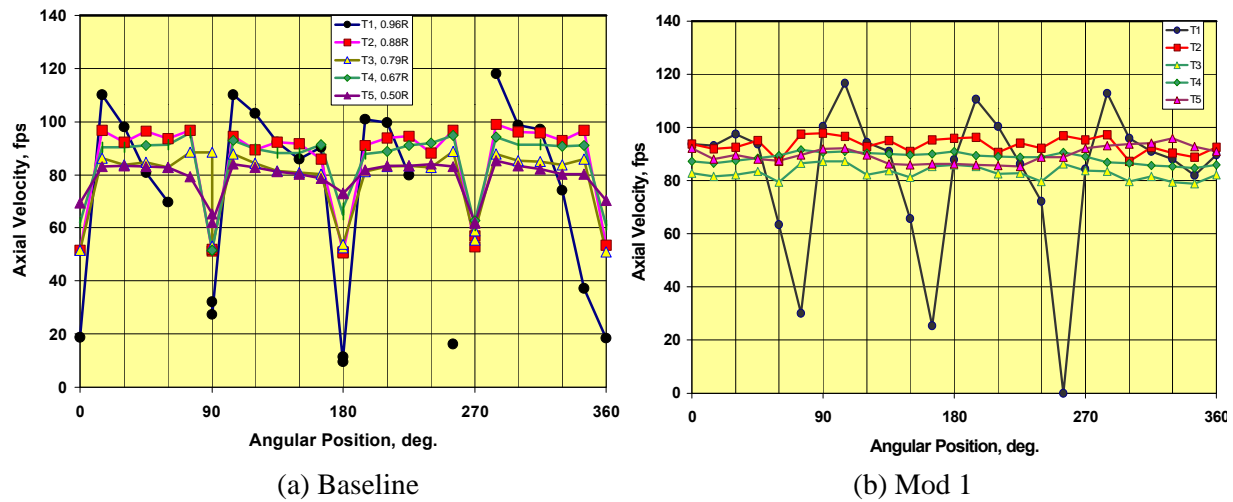
Figure 5: Air Test Axial Velocity

The first, baseline, velocity survey was carried out with the thruster and sea chest in the “as-built” configuration. The results showed strong wakes in the fore-and-aft and athwartships angular positions; corresponding to the four thick, radial plates, Figure 5a. Significant radial and tangential secondary flows were also evident, presumably associated with vorticity shed at the plate-bellmouth junctions.

The second survey, Mod 1, was carried out with all local structure removed. This was to determine just how clean the flow could be made and whether artifacts from the more distant obstructions were important, at all. The results showed very much more uniform flow except at the outermost radius, which was very close to the wall of the duct, Figure 5b. The velocity deficit was removed at 0 degrees (forward) but strong dips persisted at the other three cardinal points at this radius.

In order to quantify the value of these ultimate improvements, the ratio of estimated cavity volumes for the two cases was found. At 250 RPM, the estimated improvement at both the blade rate and twice blade rate frequencies approached 20 dB.

It was concluded that very local structural artifacts were dominating the non-uniformity of the inflow to the propeller. Redesign of these structures to interfere less with the inflow was the first priority.

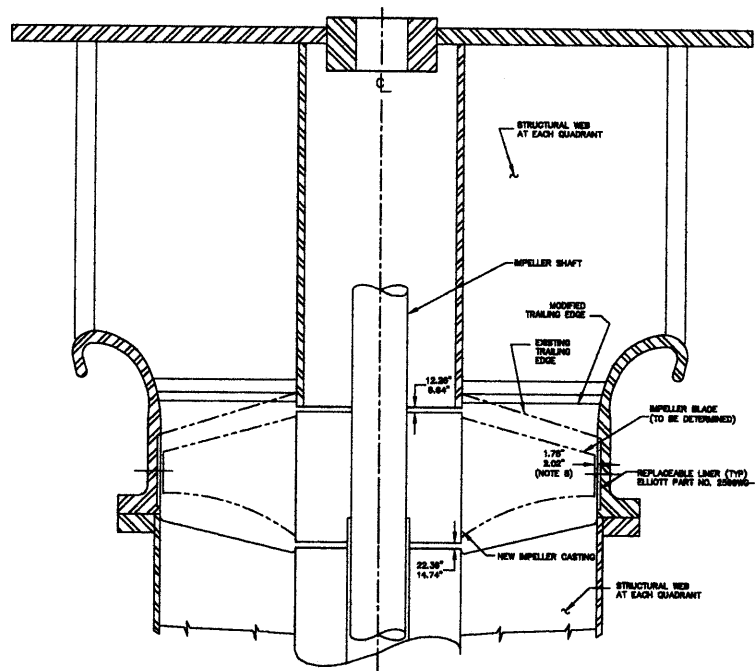
Figure 6: Thruster Modifications

As built, these same web frames extended inboard to a close proximity to the belmouth of the thruster. Considering that the sea chest was not symmetrical fore and aft across fr. 19, there was concern that fore-and-aft flow near the thruster inlet would be amplified by restriction of the passage area. As was done in ATLANTIS, it was decided to cut back the web frame in way of the thruster to increase the clearance and the area for longitudinal flow. In order to compensate for lost material, the large lightening hole in the frame was filled in.

The velocity surveys showed that the main culprits of inflow distortion were the four vertical plates which securely integrate the thruster barrel into the ship structure via the overhead and motor foundation. These plates are 1" thick (1.5" in ATLANTIS); their vertical, outer edges, that act as leading edges for the radially inward inflow to the thruster, were rather blunt. The velocity surveys indicated secondary flows characteristic of "necklace" vortices near the thruster duct wall in way of these plates. Of course, flow distortions at the maximum radius of the propeller blades does the most damage to the cavitation performance. The blunt leading edges of the plates required reshaping.

The trailing edges of the plates were quite square and were clearly generating strong wakes that were carried immediately into the leading edges of the propeller blades. In order to put a fair tail on these plates it appeared that a large amount of steel would have to be removed. Instead, the trailing edges were to be cut back to a horizontal line from their highest points at the shaft tube. This greatly increased the axial clearance between the plates and propeller at the blade tips. A new, thinner trailing edge was to be established by welding to the cut edge a 1"x 1/4" bar, centered on the thickness. Then, by grinding off thin wedges of steel from the thick plates and filling with epoxy, a new, fair tail could be created toward the lower, trailing edge of each. A large axial clearance was maintained at the tip radius. New nose pieces for the plates were to be machined from 1"x 4" bar stock, in a semi-elliptical shape. These "fixes" are illustrated in Figure 6 and Figure 7a.

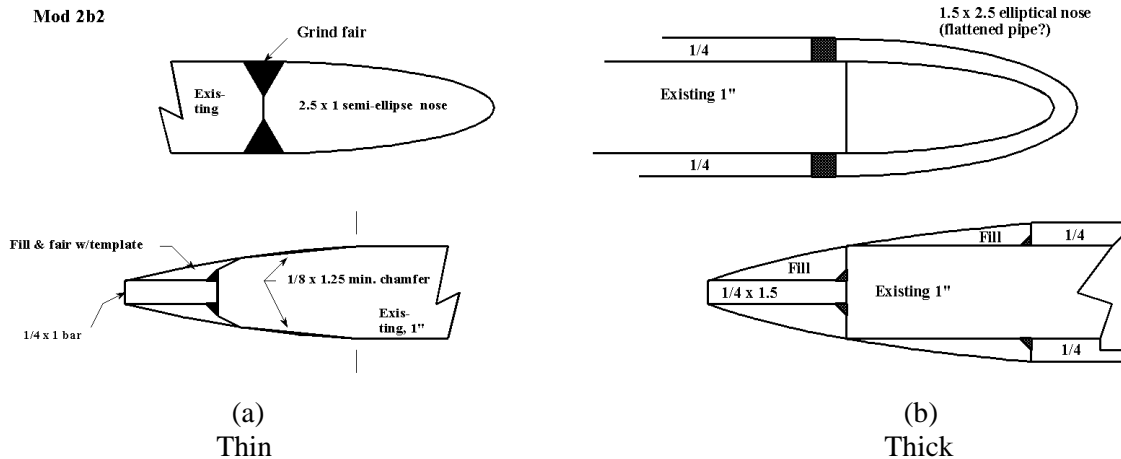
Figure 7: Plate Fairing

A second plate-shaping scheme was also tried that required less grinding. In this case, 1/4" plate was to be added to both sides to increase the thickness to 1-1/2". The tail shape was then obtainable with only epoxy filling. A nose was to be added that could be of thin plate or tubing bent to a semi-elliptic shape, Figure 7b.

A significant length of weld would be lost in cutting back the lower edges of the radial plates, weakening and softening the connections between plates and bellmouth. The bar-stock nose pieces were to be welded to the blunt outer edges of the radial plates over their full height from bellmouth to overhead, and the welds ground fair. The new welds at the bellmouth would more than make up for the strength and stiffness lost in the cutback. This procedure was approved by Elliott Turbomachinery Ltd., the thruster manufacturer.

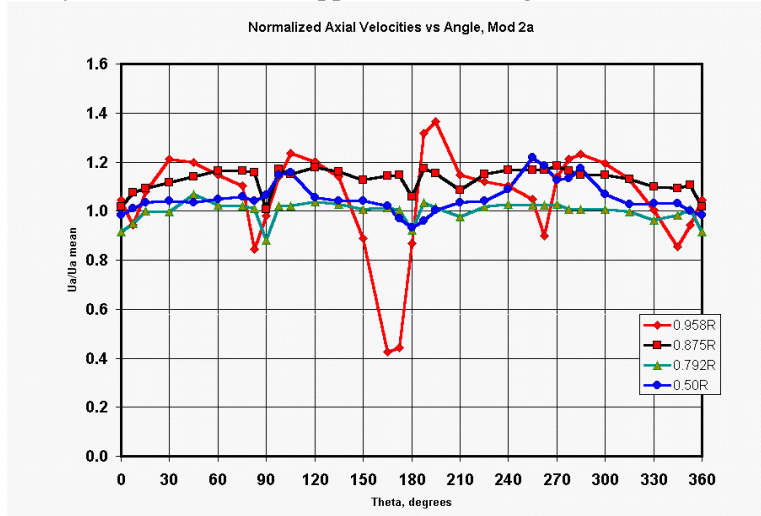
Figure 9: Air Test Normalized Axial Velocity - Mod 2

Measurements showed no evidence of the grilles in the velocity profiles. The airfoil-shaped fairings of the heavy plates were a marked improvement, with the thin version better than the thicker version. On the other hand, the steering shaft and its fairing were a concern, as may be seen in Figure 9. A large and somewhat asymmetric wake was apparent at 180 degrees

In view of the poor wake behind the attempted fairing of the steering shaft, it was decided to enclose it entirely. This was done by adding a more-or-less triangular “compartment” which landed on the after radial plate, enclosed the steering shaft, and, widening symmetrically about the centerline, extended back to the after bulkhead of the sea chest. During installation, a small sump in the overhead was relocated behind this triangular bulkhead. Unfortunately, time did not permit this modification to be evaluated in the air-test model.

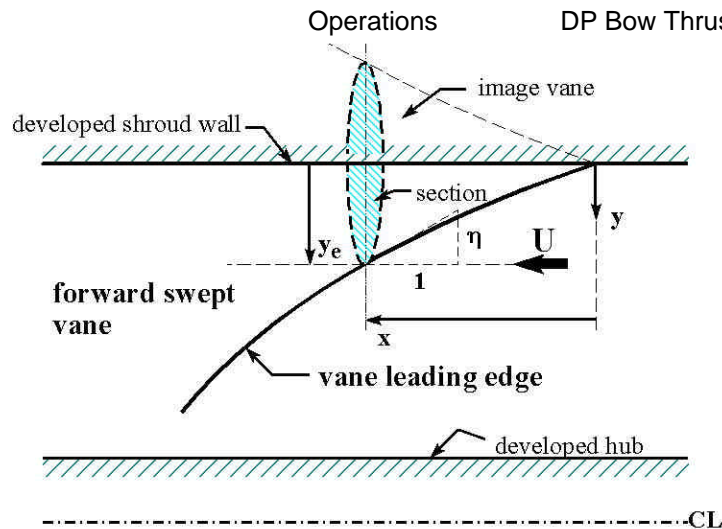
Figure 11: Forward Swept Blade (Vane) Showing Radial Section

These features are forward-skewed blades with thick nose profiles. In forward skew, the leading edge at the tip precedes that at the blade root in its normal direction of rotation. It can be shown that the tip sections lift response to a change in incidence is reduced by forward skew relative to no skew, and markedly so to the more usual back-skew. The smaller lift change is accompanied by a smaller reduction in blade back pressure, resulting in greater cavitation tolerance to incidence. Similarly, a thin, sharp leading edge is extremely intolerant of incidence changes for cavitation. A rounder, hence thicker, leading edge generates smaller pressure reductions when subjected to incidence changes, and is therefore preferable in non-uniform flow. The bluntness of leading edges is limited by “thickness” cavitation inception at the “shoulders” when operating at design incidence. If the maximum leading edge nose radius is limited by the smallness of the ambient cavitation number, σ , the local leading edge sweep angle necessary to avoid incidence cavitation can be related to the nose radius by:

This is based on a low-aspect-ratio (LAR) approximation “model” of a ducted propeller swept (skewed) blade, Figure 11. In LAR, spanwise (radial) blade sections are examined and their flow properties related to the usual chordwise sections.

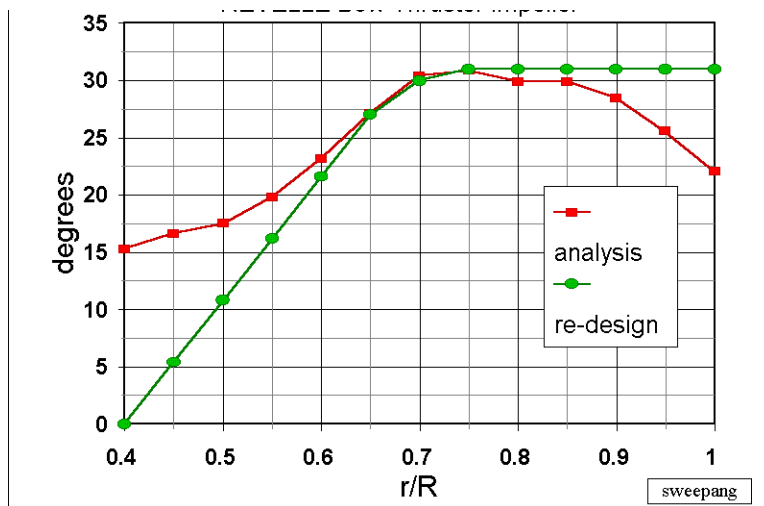
Figure 12: Leading Edge Sweep Angle vs Radius

The above relationship can be integrated to delineate the blade leading edge profile viewed in axial projection, in polar coordinates, (r, θ) :

In order to be conservative, the original, unimproved velocity survey was retained as the basis for the blade redesign. Assuming a nose radius that represented no more than 25% of local blade maximum thickness the leading edge skew profile, Figure 12, was worked out for nominally equal speed of cavitation inception for all blade sections. The skew profile to be built, Figure 13, was selected from this computed one.

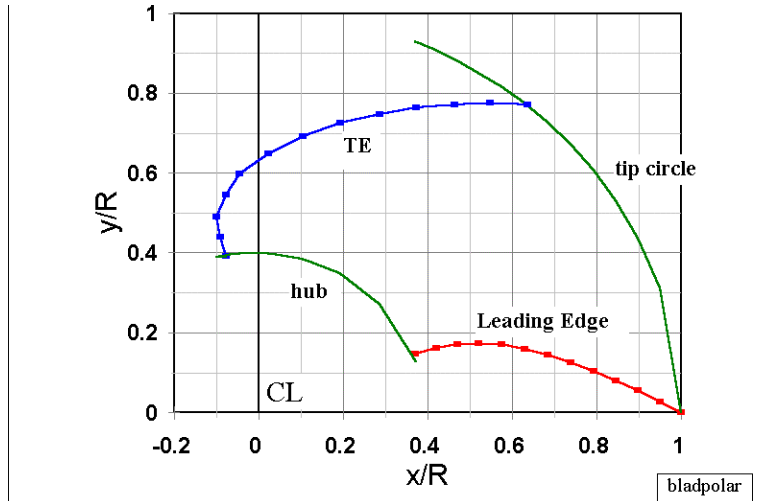
Figure 13: Axial Projection - Forward Skewed Blade

While introduction of forward skew and thick leading edges may seem radical, it was desired to minimize changes from the existing propeller design, one that had been in service for many years. In that regard, the chord length and thickness of each original blade section were maintained. It was necessary to adjust the pitch distribution, however, in order to maintain the original distribution of loading over the radial extent of the blades. This is because the forward skew tends to unload the blade at the tip. Bird-Johnson Co. applied propeller lifting surface theory modeling to determine the pitch distribution that would maintain the original load distribution with the new skew. The resulting pitch was somewhat increased at the tip, relative to that of the original un-skewed design.

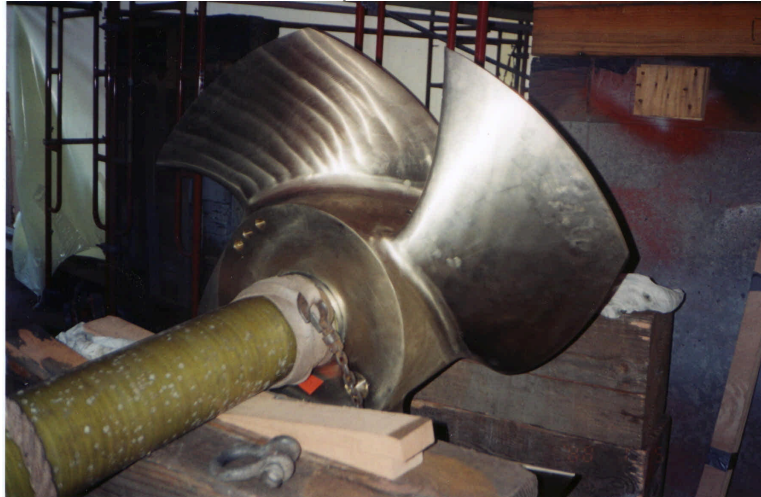
Figure 14: New Thruster Propeller

A pattern was made and a mono-block propeller cast by Bird-Johnson Co. at their Pascagoula foundry facility. The propeller was machined and hand finished to Class I requirements and delivered to an Elliot-approved company for dynamic balancing. All material removal for balancing was from the hub; the blades were not disturbed. At Southwest Marine shipyard, where REVELLE was in drydock, the thruster was disassembled and the new propeller, Figure 14, installed under Elliot supervision. Modifications to the thruster structure were going on at the same time.

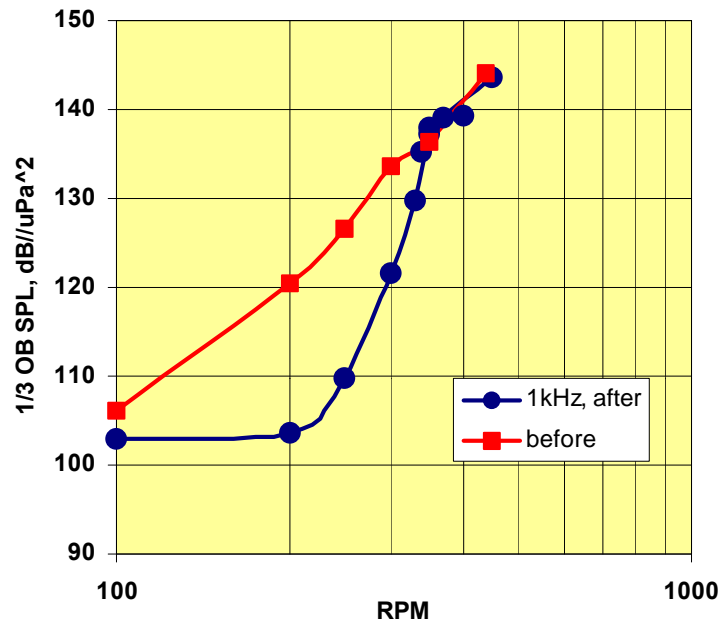
Figure 15: Underwater Noise-REVELLE Bow Thruster

The most direct indication of thruster cavitation performance is in its underwater radiated noise. In Figure 15 there are displayed the underwater sound pressure levels as a function of revolution rate, at a particular position outboard of the thruster, both before and after the above modifications. A frequency band centered on 1000 Hz. is used. It can be seen the modifications have increased the cavitation inception speed to about 250 RPM from an indeterminately low value. The resulting noise reduction in this frequency band is a valuable 15 dB, or so, in the mid RPM range. At speeds less than that for cavitation inception, there is no cavitation noise; the measured levels are due to other, or ambient sources.

The purpose of the modifications to ship and thruster was to increase the speed of cavitation inception to the point where habitability noise levels would be acceptable during DP operations. This was accomplished, since in REVELLE, DP operations usually require half the rated thrust, or less. Unfortunately, we cannot determine from the test data what the individual contributions were of propeller redesign and structure reconfiguration to the observed cavitation performance improvements. Figure 17, showing the frequency spectrum of noise levels in room 2-22-2, reveals that, with the exception of the 1 kHz. band, noise levels are reduced across the board. The underwater noise measurements displayed in Figure 15, being for 1 kHz., would not suggest this favorable performance.

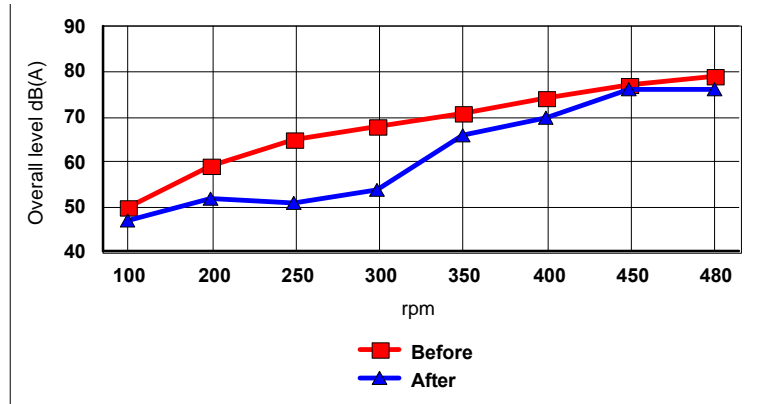
Figure 16: Room 2-22-2 Overall Noise Levels, REVELLE

resonances. The before-and-after noise levels in room 2-22-2 are plotted vs. thruster revolution rate in Figure 16. This stateroom, housing two scientists, is immediately aft of the thruster, inboard, on the first platform. The Overall Levels are so-called “A-weighted,” single number values representing the frequency-integrated acoustic energy levels sensible by the human ear. It may be seen that up to 350 RPM, the noise levels in this room are now nearly unaffected by thruster operation. That revolution rate represents approximately one-half of the rated thrust of the unit. The apparent noise reductions achieved in this operating range are, like those in the underwater noise, about 15 dB.
