Risk Analysis of a Dynamic Positioning Diving Vessel Up Weather of a Platform and Jack Up

Doug Phillips
American Global Maritime

DP Risk Analysis

Up Weather DP Dive Vessel

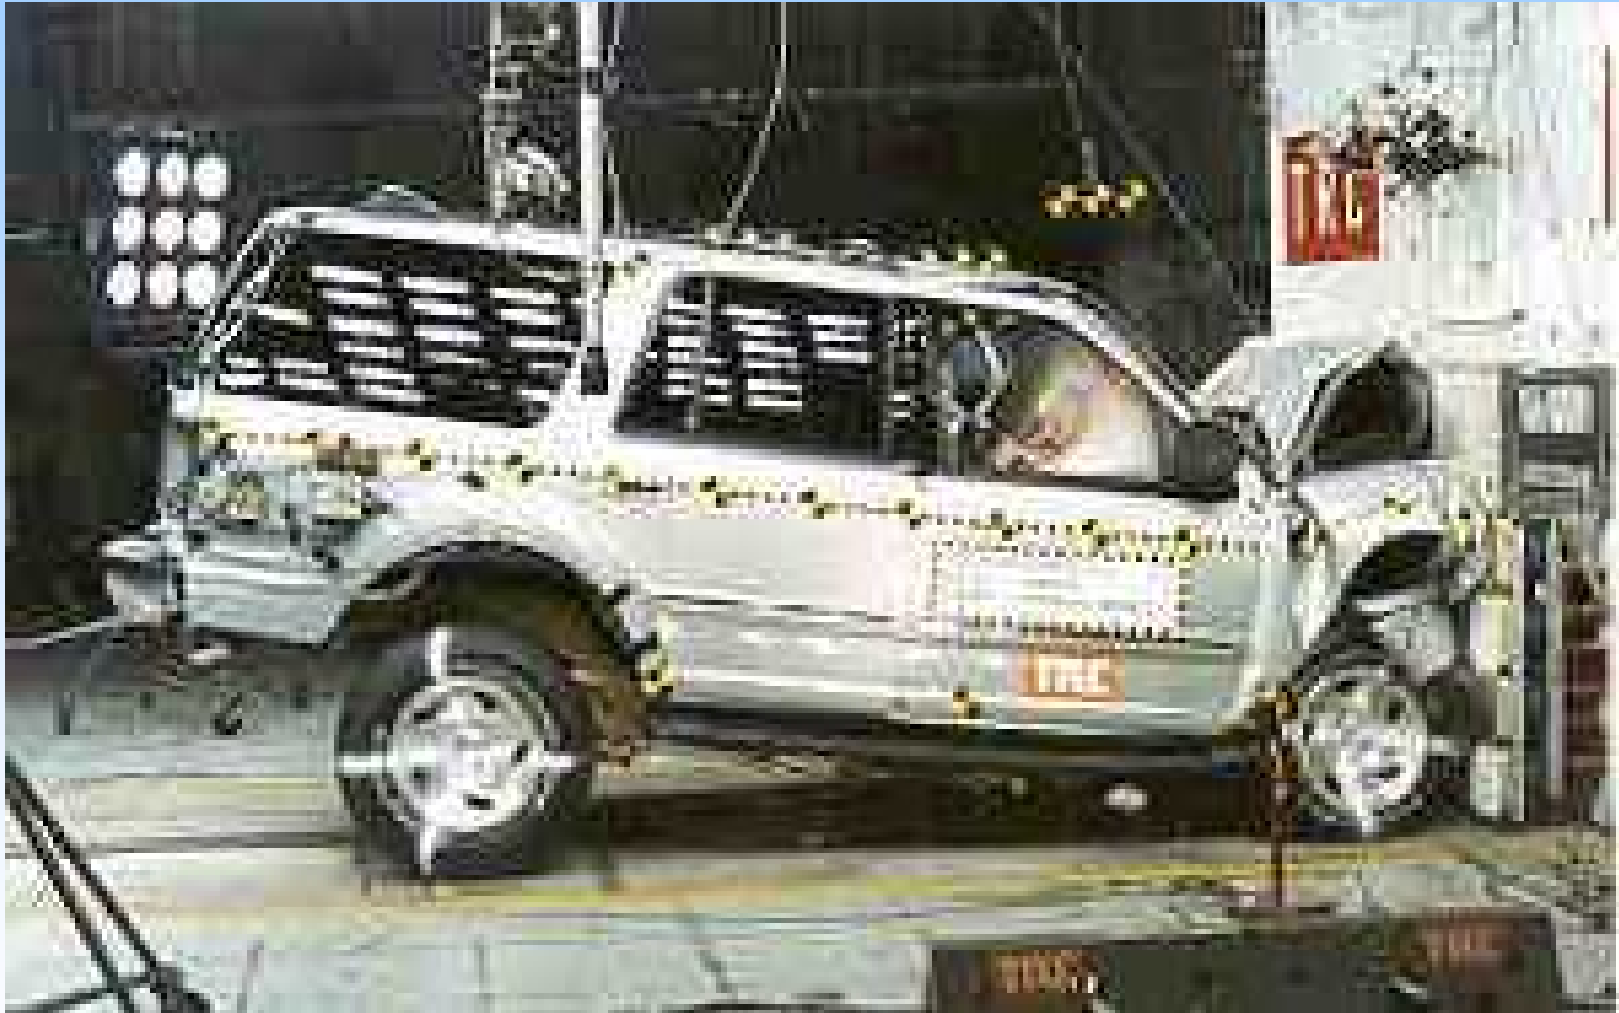
- 5800 lb SUV with 800 lb pay load (3 Tonne) at 30 mph
- 0.25 MJ

$\frac{1}{4}$ of a Mega Joule?
