DYNAMIC POSITIONING CONFERENCE

Operations and Requirements

FPSO and Shuttle Tanker Positioning

Chris Jenman
Global Maritime, Inc.

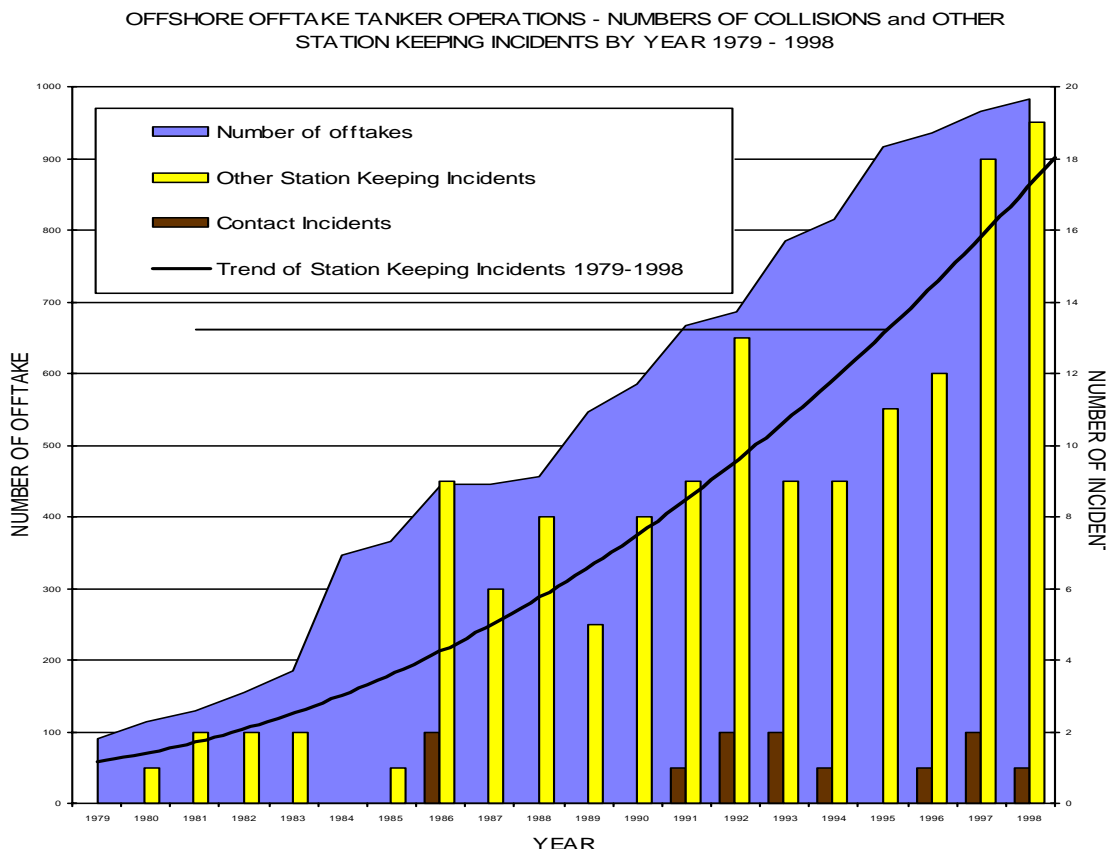
In 1998 a joint industry project was set up because collisions seemed to be increasing but this was difficult to quantify because there was also an increase in the exposure. The result of this study (Ref 1) which covered all areas of the world from which data could be obtained and DP as well as non DP tankers, showed that collision frequency was too high. It also showed (see figure below) that there had been a significant increase in tanker offtake operations between 1979 and 1998.

The other features of this graph that are interesting are that in 1984 and 1985 there were few incident reports. In 1986 there were two collisions and the reporting of lesser incidents increased significantly. Reporting then decreased until the next collision in late 1991 and the two collisions

in 1992. This feature; a sudden increase in near miss incidents is then repeated again in 1997. This is a caricature of human nature. A reduction in near miss reports can signify a real improvement or just be the lull before a storm. The collision frequency was 5.89×10^{-5} per DP hour. However this frequency was for all collisions and many were with the loading point; a buoy or tower structure. In these cases the clearance distance was less (about 40m) whereas the FPSO-shuttle tanker distance is about 70m.

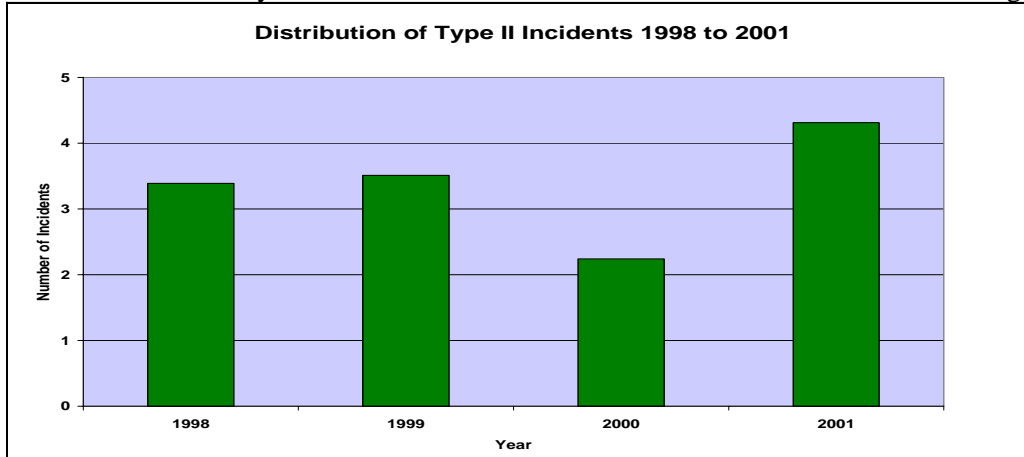
In 2001 they wanted to check if their target of 25% reduction in incidents had been achieved. (Ref 2) The results showed that there had been 16 level 2 incidents but that only 6 of these had been reported to the UK HSE. This was a disturbing fact. However out of these incidents there was only one collision with an FPSO and on this basis the improvement was 59% to 2.4×10^{-5} . The improvement target was not met if a collision with a loading buoy was also included. Also the trend over these four years showed little downward movement. At best it was unchanging.

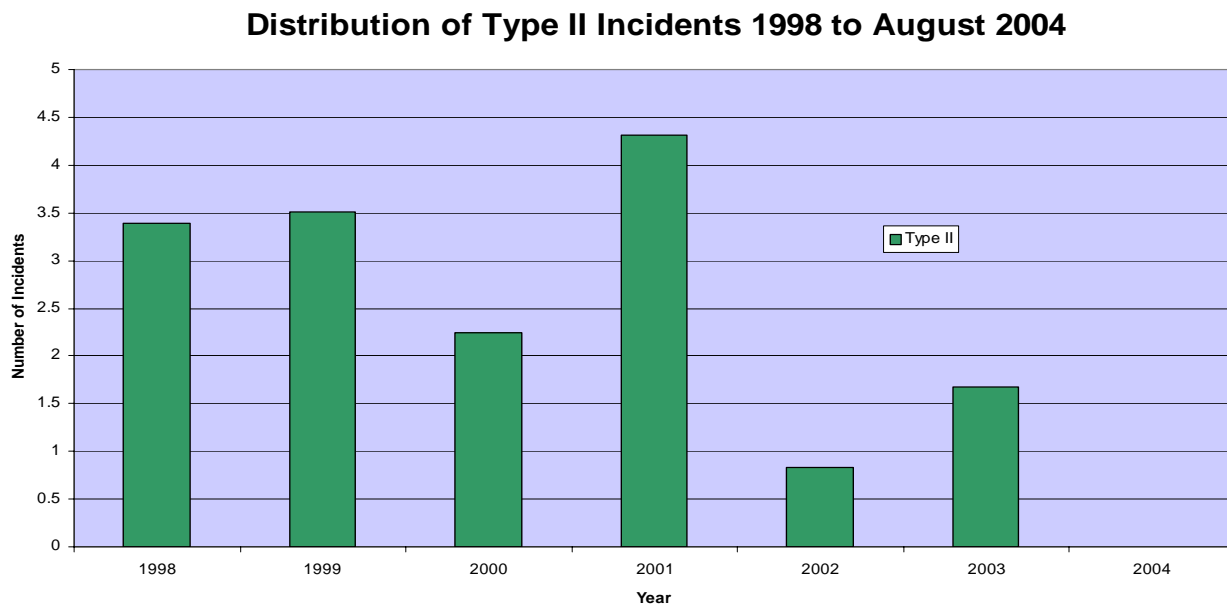
The UK HSE agreed that rather than wanting a 25% improvement for all types of incident, they would consider their goal to be met if there was an improvement in the level 2 incidents because these were reportable under their RIDDER (Ref 3) system. An increase in the reporting of lesser incidents or events would not cause them concern but would be considered a good thing. The 2001 check of progress was also before the UKOOA FPSO Committee published their guidelines in 2001 (Ref 4). As can be seen from the figure below there was a significant reduction in level 2 incidents in 2002 – 2004 and there were no type 1 incidents.

So the collision frequency for the period 1998 – 2004 was reduced to 1.45×10^{-5} taking the UKCS alone. The more significant factor was the trend reduction in this level (level 2) of reported incidents. No data has been collected for the HSE since this time. However data has been supplied to IMCA by Teekay in Norway. Teekay is the only shuttle tanker operator providing data and from their data the number and the seriousness of incidents has reduced in 2004 and again in 2005. At the height of the concern it was agreed that not only would tanker operators supply data but also FPSO operators would contribute if this meant a duplication of data. This only took place a couple of times.

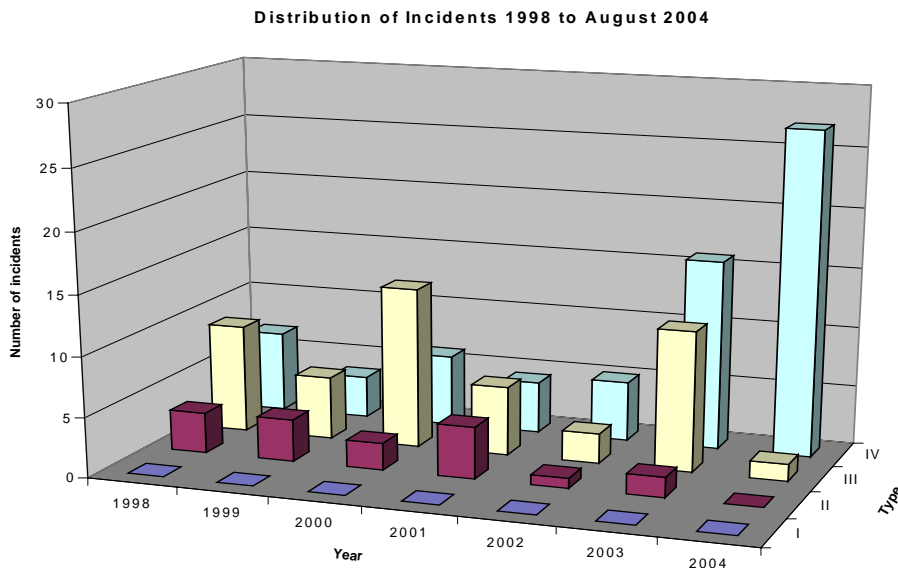
For the trend of all levels of incident (or event) reporting there have however been some encouraging signs. The figure below shows that there has been an increase in the level 4 over 2003 and 2004. This is considered a good thing.

It is difficult however to be sure that this shows better reporting from a technical and safety point of view because much of it is downtime related which is to do with contracts and money. Nevertheless the conclusion could only be that there has been a significant improvement. The causes of this improvement can be summarised as follows:

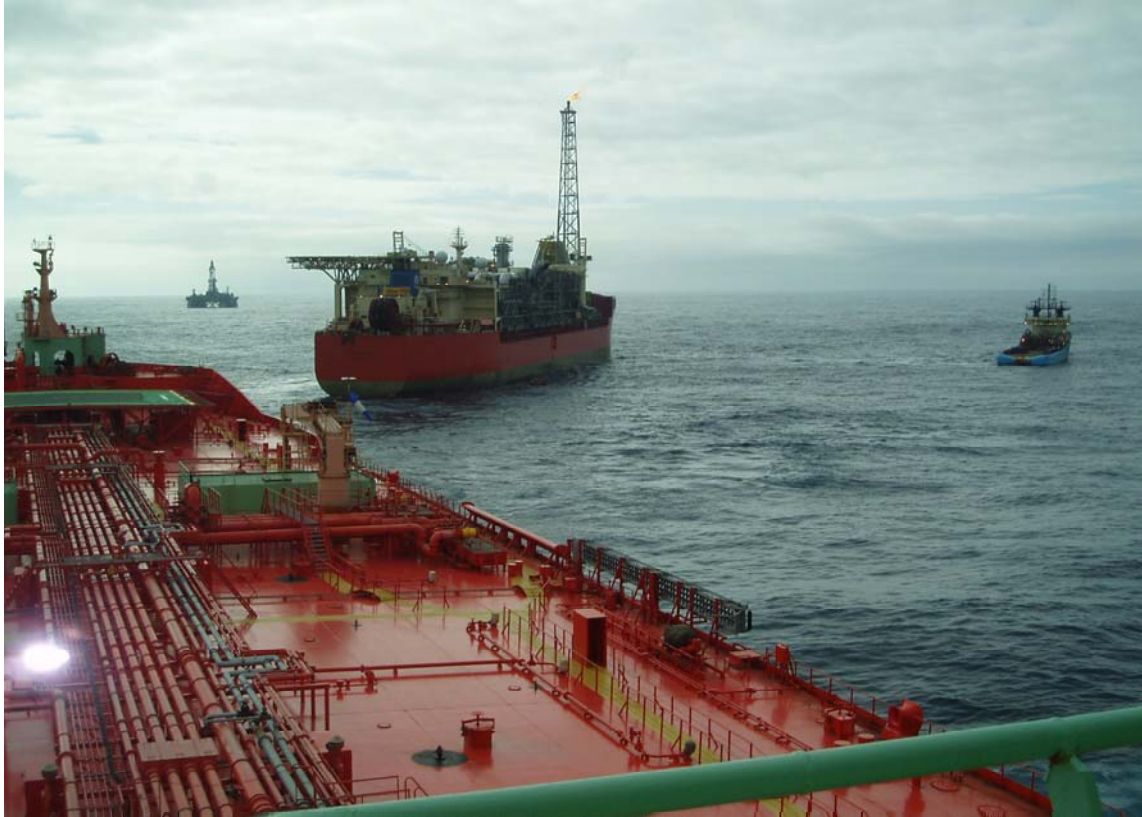
The hardware and software improvements have been significant but this also means that there are different DP control systems not just between Converteam (Alstom) and Kongsberg but also between different software releases from the same supplier. The other major change is the systems installed on the FPSOs. On the Terra Nova FPSO heading control is always used for offtake operations and the heading for the approach and offtake operations is decided between the FPSO and the shuttle tanker Master. On the Sea Rose FPSO installed in the same sea area and now served by the same shuttle tankers heading control is not used. When Masters, familiar with Terra Nova first came to White Rose Field the difference in approach and the sudden thruster activity during loading caused some concern. In some instances the misalignment becomes so great that the whole approach has to be aborted and restarted. The picture below shows such an approach. The misalignment became $>60^\circ$ at a late stage of the approach.
